SEAKEEPER CODE 56 DISCUSSION

PRODUCT SEAKEEPER 1, 2 and 3 MODELS

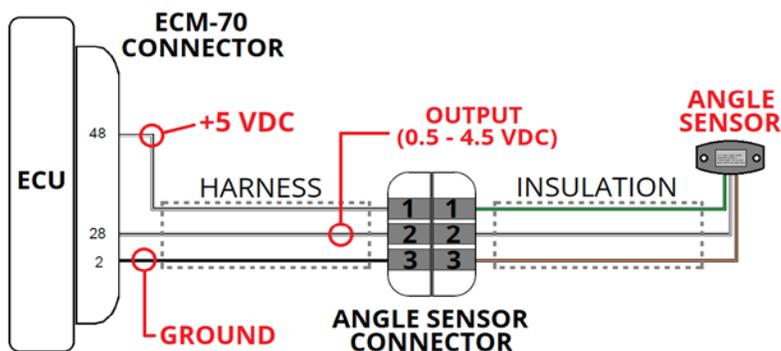
Angle Sensor Wiring Scheme for a Seakeeper 3

If the angle sensor ground wire were to become disconnected from the ECU, the angle sensor would transmit an angle reading of about 39°. This could result in unintended sphere motion at a high rate and or into its end-stops that would go undetected if not for Code 56. The Code 56 software algorithm seeks to identify this scenario by evaluating if the angle reading has failed to change as expected, given the sea state in which the Seakeeper is operating.

Should a dealer respond to a Code 56 service request, verify the continuity of the ground wire from the angle sensor to the ECM-70 connector pin 2 (pin 32 on Seakeeper 2). If an open line is found in either the wiring harness or the angle sensor leads, the alarm is valid, and the component should be replaced. Otherwise, the alarm was a nuisance alarm and should be reported in the Service Report Form.
