CODE 251 CONNECTIVITY ISSUES UPDATE

PRODUCT SEAKEEPER 1

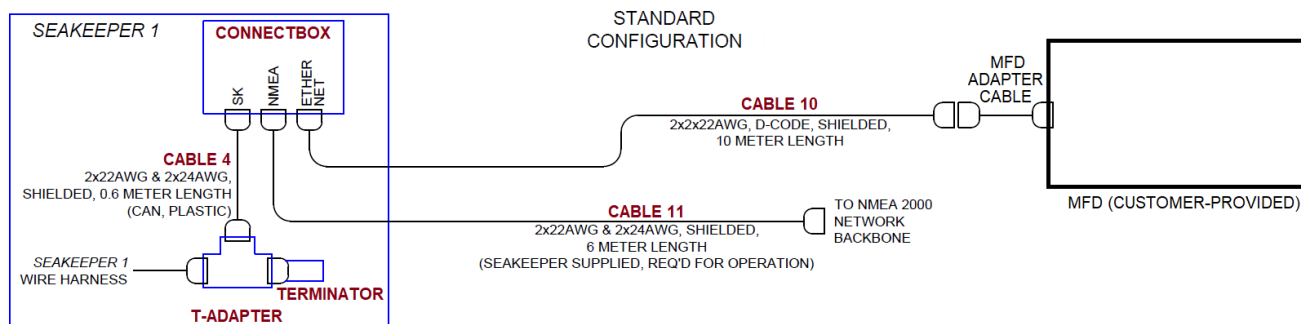
If the Seakeeper-to-MFD link (Cable 10 and MFD adapter cable) were faulty, the Seakeeper MFD web app should fail to open or set web app exception overlays. The Code 251 suggests the issue is in the connection between the ConnectBox and the ECU, most likely due to connection issues; failure of the T-Adapter, Terminator (resistor), or cable 4; or damage to ConnectBox ports.

This is supported by the fact that when a 5" display is installed at the Seakeeper onto the gyro CAN network (not the NMEA network), the display works. Removing the 5" display and reconnecting the MFD works for an undetermined amount of time before the MFD displays Code 251 again. The Cable 4, Terminator (resistor), T-Adapter, or ConnectBox port is suspect in this event.

If the Seakeeper web app fails to appear or has intermittent connectivity issues on an MFD, update to the latest versions of the ConnectBox/Display/MFD software. Refer to the appropriate Technical Bulletin, 90478 (Garmin), 90479 (Raymarine) or 90480 (Simrad) to configure the ConnectBox/Displays after programming. If connectivity issues persist, consider the connections or integrity of cable 10. Seakeeper has received feedback of regular nuisance Seakeeper web app exceptions received by customers. There is a software update that should address the nuisance web app exceptions that appear on the MFD screens.
