SEAKEEPER CAN CORRECTION - 90504

PRODUCT SEAKEEPER 2 & 3

To correct a CANbus CAN LOW connection problem in Seakeeper 2 and Seakeeper 3 stabilizer wire harnesses.

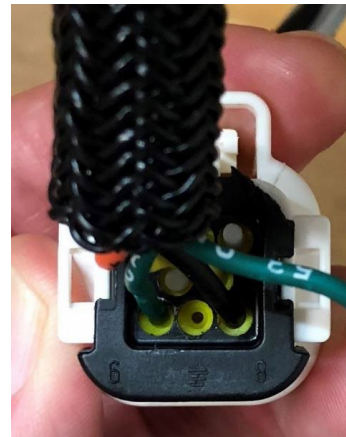
Rear view of MDB connector.
Position 6 at lower left and position 8 at lower right, green wire removed from position 7.
This procedure will cut the position 7 wire.

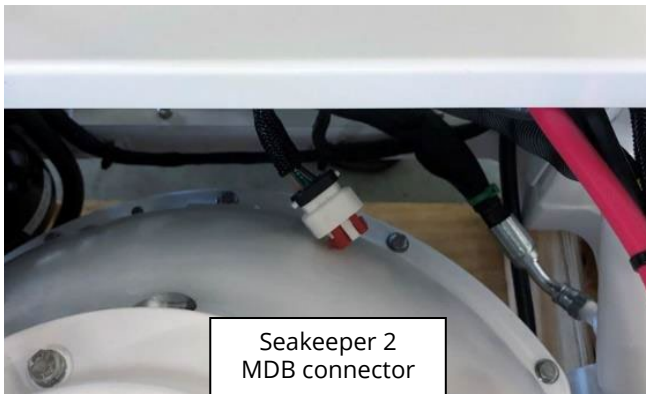
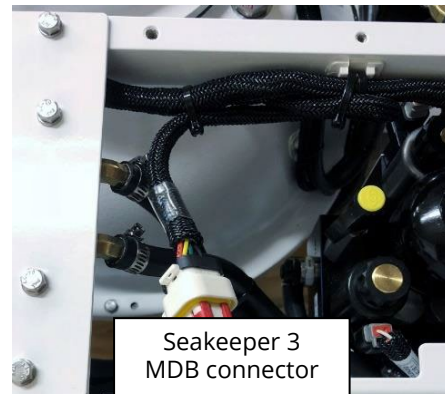
1. **ENSURE** Seakeeper flywheel at zero RPM at display/MFD app.
2. **OPEN/TURN OFF** all DC power breaker to Seakeeper.
3. **DISCONNECT** MDB wire harness connector.

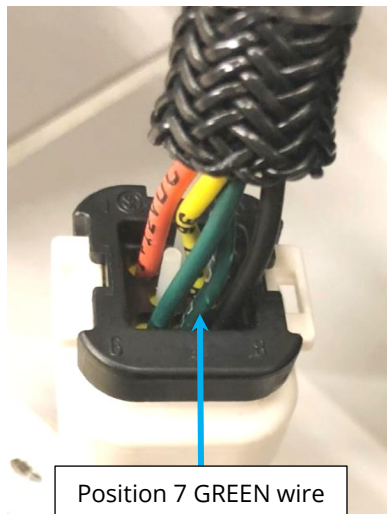
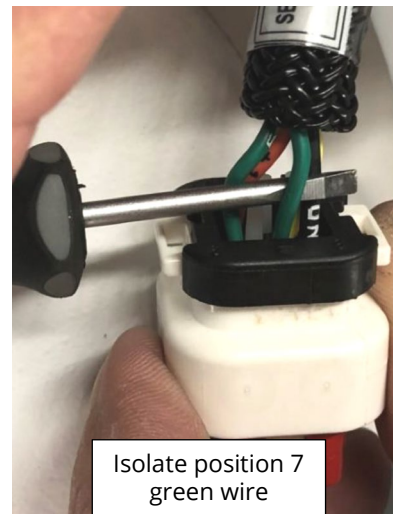
4. **LOCATE AND SEPARATE** green wire at position 7 from other wires with small flat-blade screwdriver.

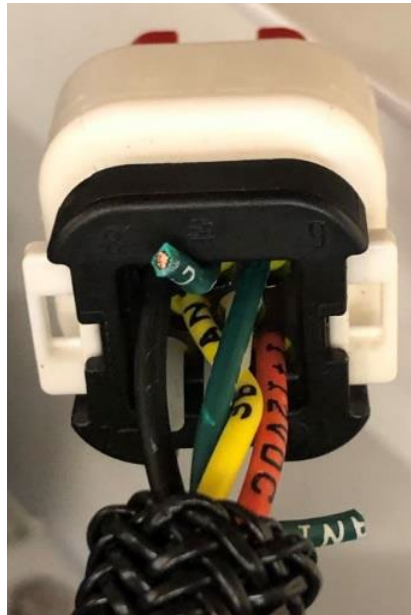
5. **CUT** position 7 green wire.

CUTTING OTHER WIRES WILL AFFECT OPERABILITY OF SEAKEEPER.

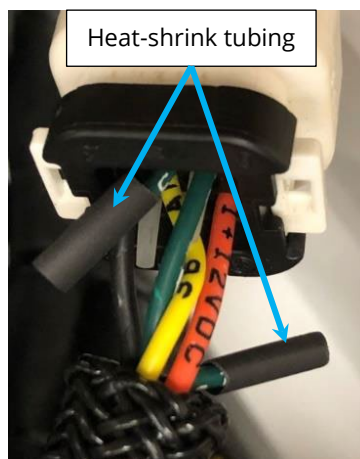
6. **PLACE** ½" pieces of 1/8" heat shrink over two cut wire ends with tubing extending beyond wire ends (to be pinched together later).

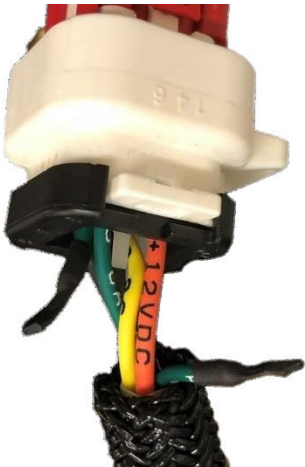
Seakeeper 2 annotation

- 7. **APPLY** heat to tubing **AND PINCH** ends of tubing with long-nose pliers to create seal.
- 8. **TUCK** sealed wire ends back into wire bundle.
- 9. **RECONNECT** MDB connector.
- 10. **LOCATE** Seakeeper GCM inside front cover **AND DISCONNECT** GCM connector from GCM.
- 11. On tag of wire bundle to GCM connector, **ANNOTATE** new revision number for harness with fine point permanent marker (**Rev 8** for Seakeeper 2 or **Rev 5** for Seakeeper 3).

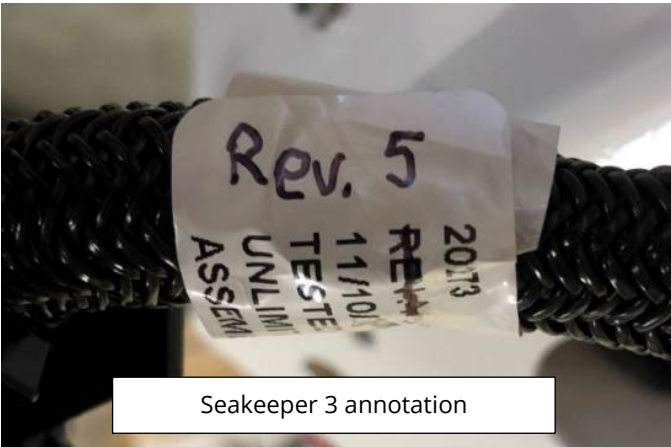
Seakeeper 3 annotation
