SERVICE WORK INSTRUCTION

SEAKEEPER FOUNDATION BUSHING REPLACEMENT

PRODUCT SEAKEEPER 26/20HD & 35/30HD/40/M21000, M21000A & M26000

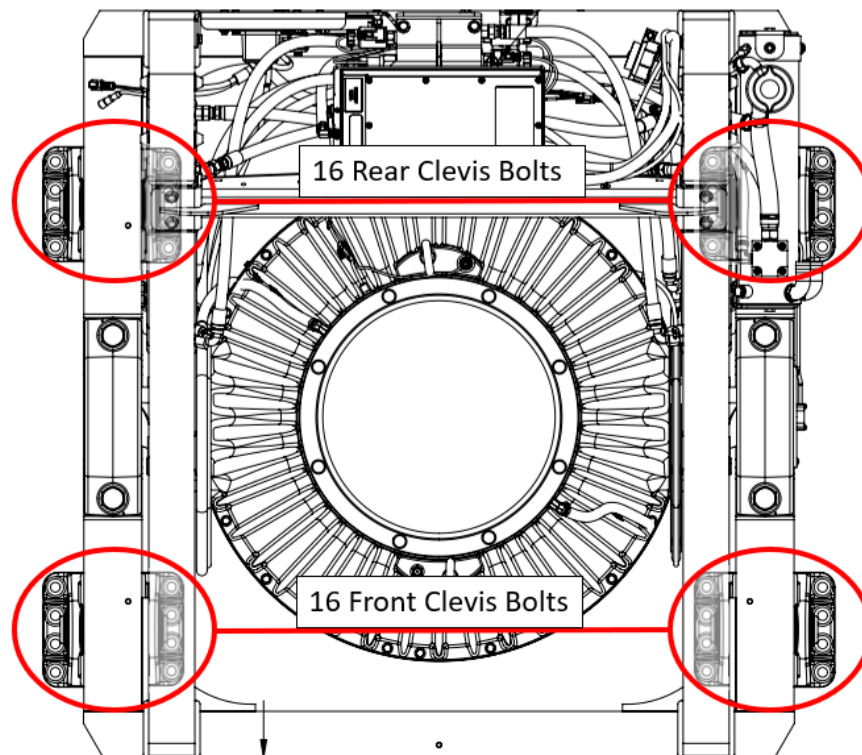
1. **REMOVE** all 16 mounting screws of either front or rear end clevis assemblies to stringer/saddle with 24 mm socket.

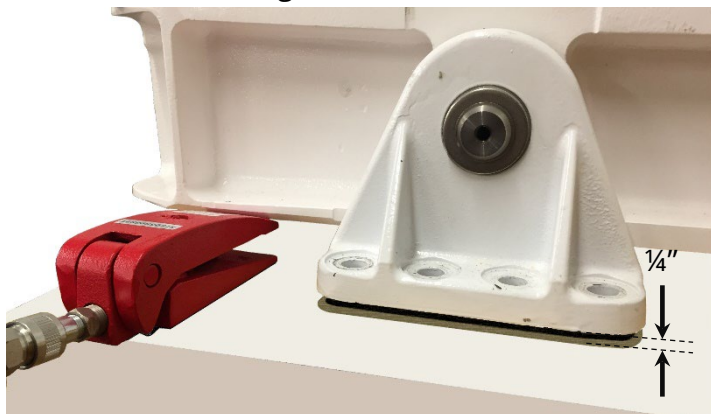
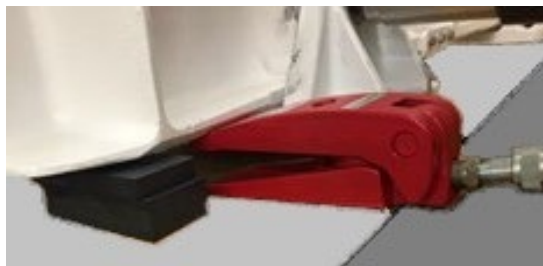
4. **SUPPORT** foundation with plastic blocks, so bottoms of clevis assemblies are about 1/8 to 1/4 inch off stringer/saddle.

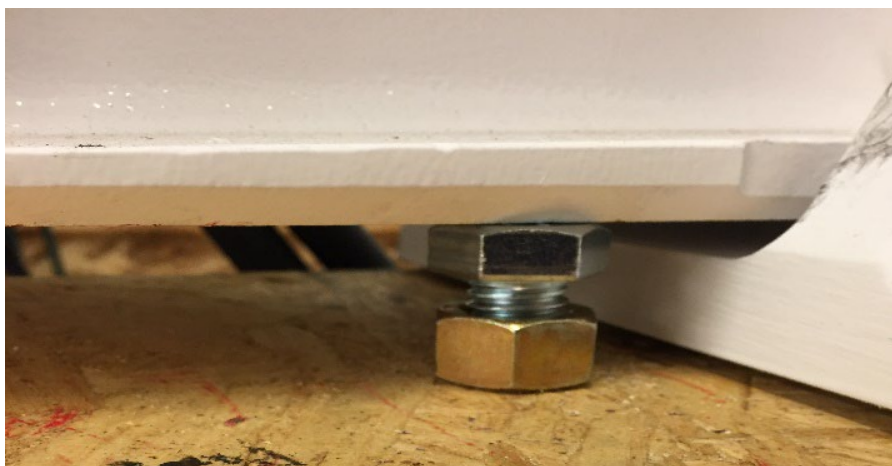
5. **IF** clevis will not separate from stringer using hydraulic jack, **THEN APPLY** additional pressure using supplied nut and bolt.

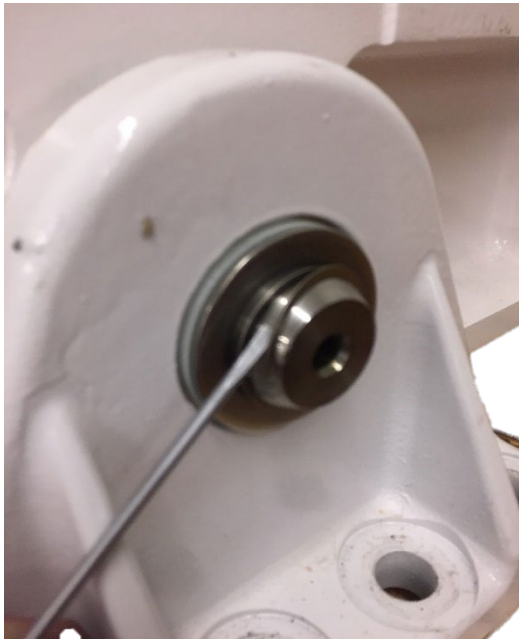
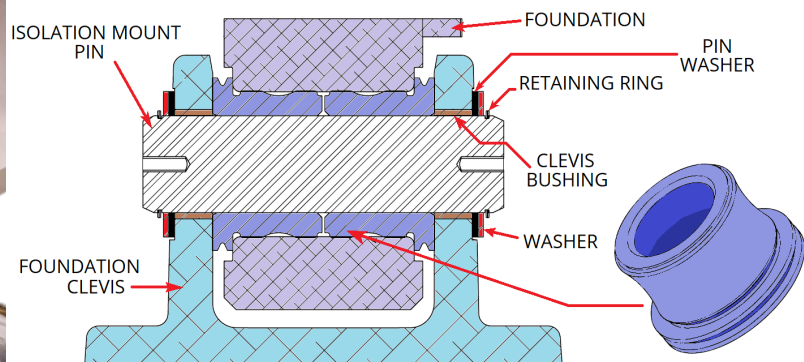
- a. With small straight tip screwdriver, **REMOVE** spiral retaining ring and washers from clevis pin.

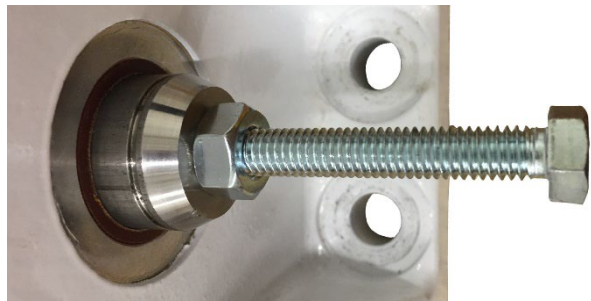
By tightening the lock nut on the 3/8-16 bolt, the bolt can be used to apply twisting force on clevis pin to assist in removal.

- b. **DRIVE** out isolation mount pin using a 3/8-16 machine screw, nut, and mallet.

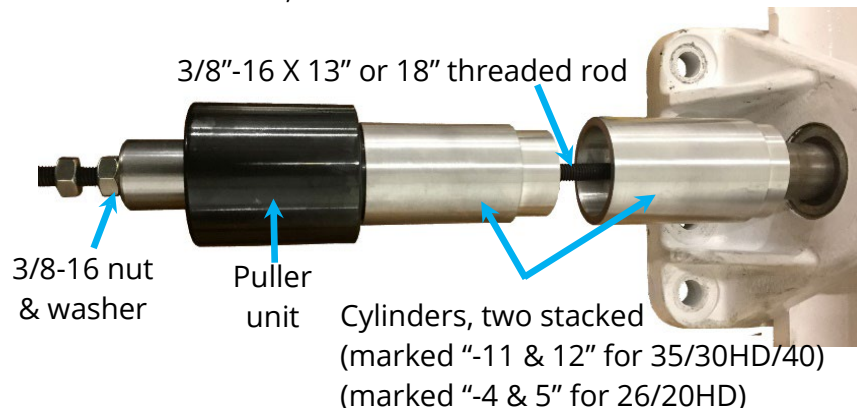
- i. **APPLY** hydraulic ram to remove pin, as shown below, from either inside or outside foundation, whichever is easier.

- ii. **PUMP** hydraulic pump to pull pin into cylinders.
- iii. **WHEN** puller runs out of stroke,
THEN RELIEVE hydraulic pressure, **TIGHTEN** nut and washer **AND CONTINUE** pumping until pin released.

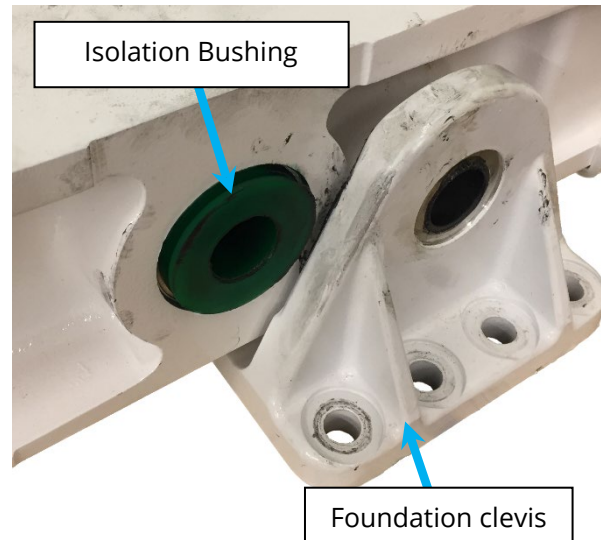
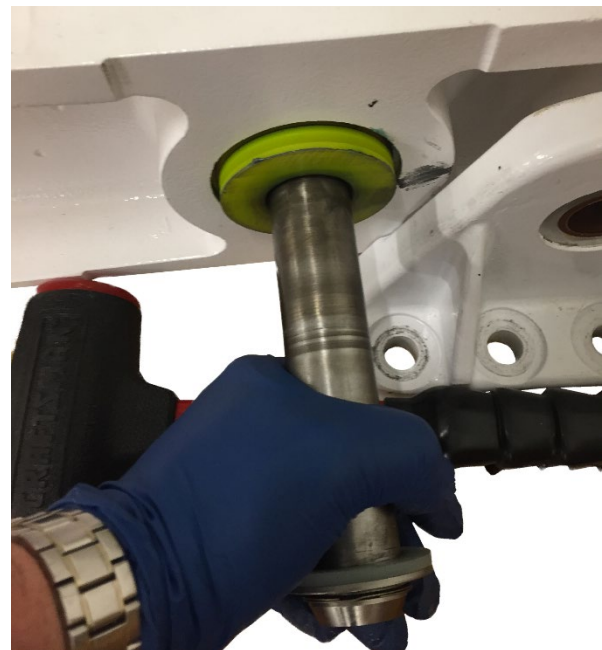
7. **REMOVE** urethane isolation bushings as follows:
 - a. **SLIDE** foundation clevis off isolation bushings and toward gimbal shaft by using a rubber mallet.
 - b. **REMOVE** urethane bushings using isolation mount pin as lever to pry out bushing.

Tapping on outside of clevis while putting pressure on inside helps slide clevis off bushing.

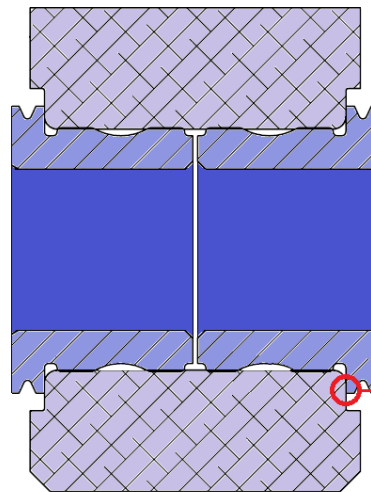
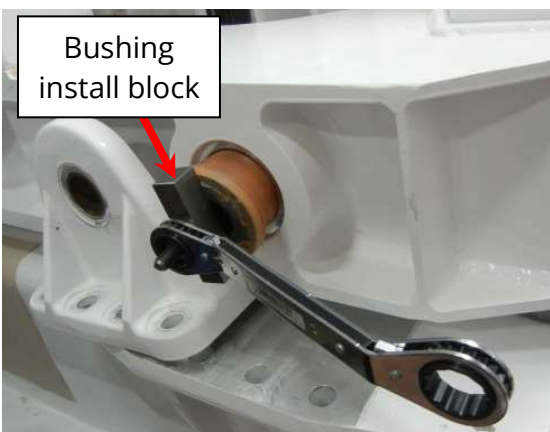
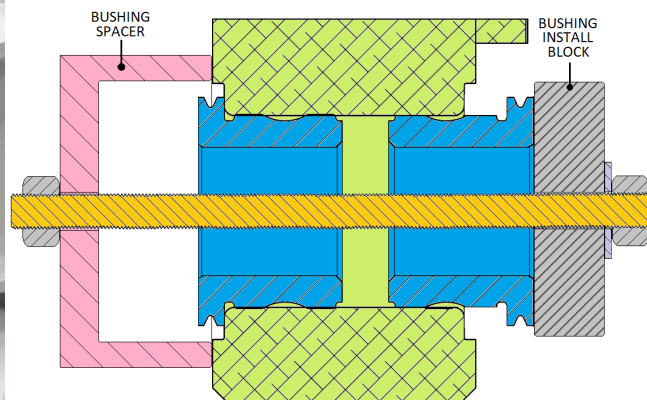
- c. **DRIVE** new bushing in flush to shoulder of bore with bushing install block (PN 11956), threaded rod, two nuts, and bushing spacer (PM 80288-3 or 80287-3).

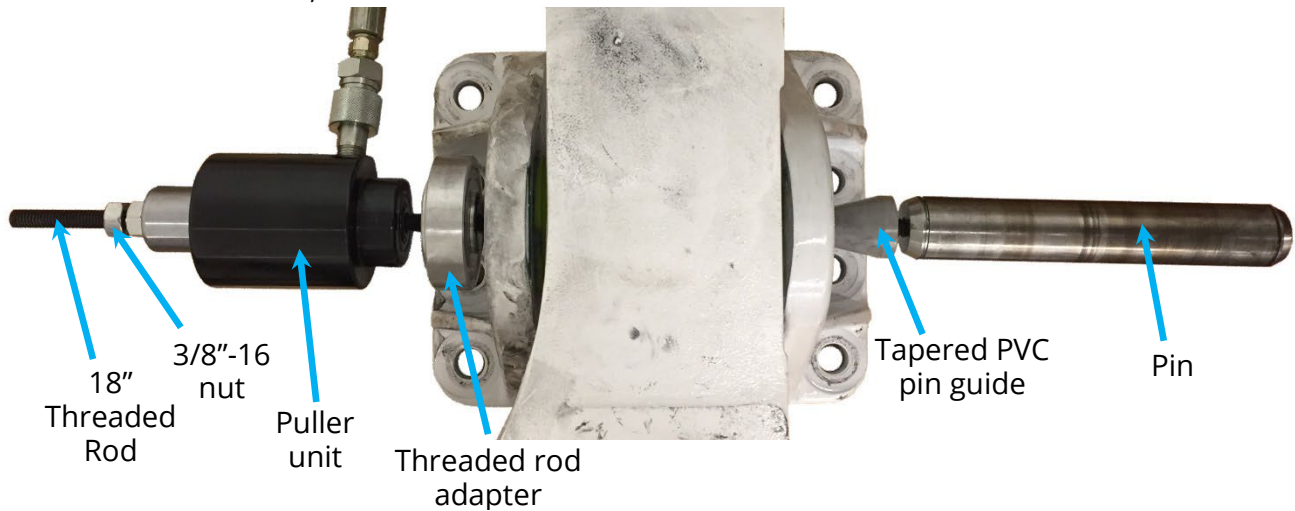
- f. **APPLY** thin film of black moly grease to isolation mount pin.
- g. **ASSEMBLE** components, as shown, to reinstall pin from either inside or outside of foundation, whichever is easier.

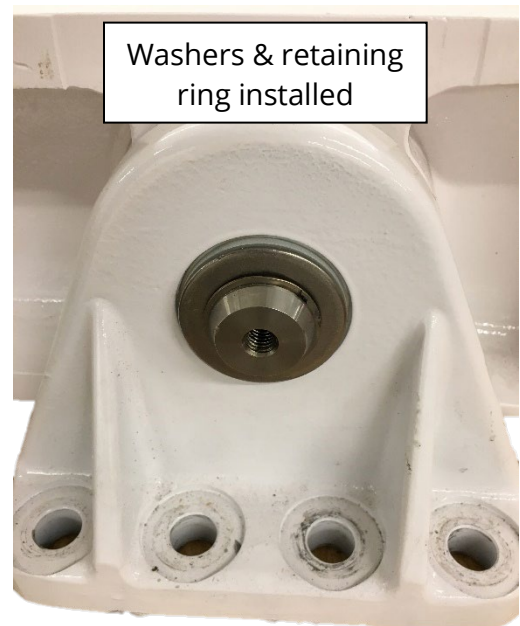
- h. Using tapered PVC Pin Guide, to align pin in opening, **DRIVE** isolation mount pin into clevis as shown.
 - i. **PUMP** hydraulic pump to draw pin into isolation bushings.
 - j. **WHEN** puller runs out of stroke, **THEN RELIEVE** hydraulic pressure, **TIGHTEN** nut and washer **AND CONTINUE** pumping until pin is fully inserted.
 - k. **INSTALL** washers and new spiral retaining rings on both sides of pin.
11. **APPLY** marine grade silicone to bottom of each foundation clevis.
