TROUBLESHOOTING GUIDE TABLE OF CONTENTS

INTRODUCTION

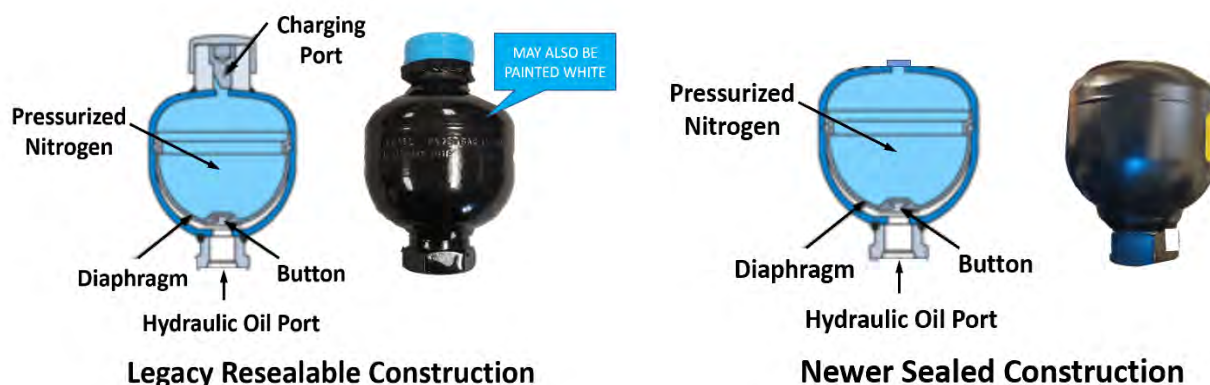
An Accumulator diaphragm can fail and allow nitrogen and oil to mix. When looking in the hydraulic oil port of an accumulator the plastic "button" of the diaphragm should be visibly pressed up against the opening. If the diaphragm has failed it will often deflate entirely within the accumulator, but may not, due to being filled with oil.

A legacy resealable accumulator may also commonly fail due to nitrogen leaking out of its resealable charging port. All or some of the nitrogen pressure may be lost impacting performance. The nitrogen cannot be recharged in the field.

If an accumulator has failed, it should be returned to Seakeeper if under warranty. If the Seakeeper unit is not under warranty, dispose of accumulator in accordance with local ordinances, unless requested by Seakeeper Product Support Team.

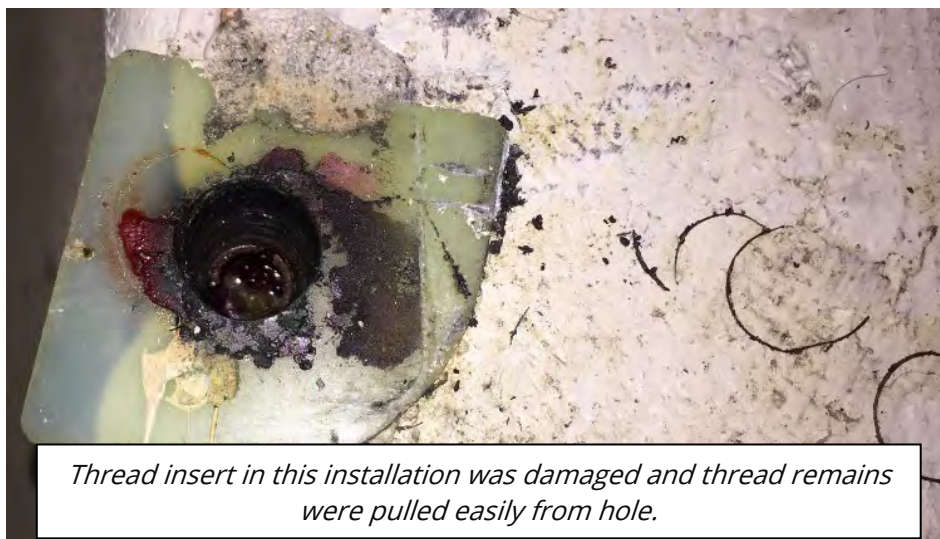
Thread insert in this installation was damaged and thread remains were pulled easily from hole.
