PRODUCT SEAKEEPER SERIES MODELS

TROUBLESHOOTING GUIDE TABLE OF CONTENTS

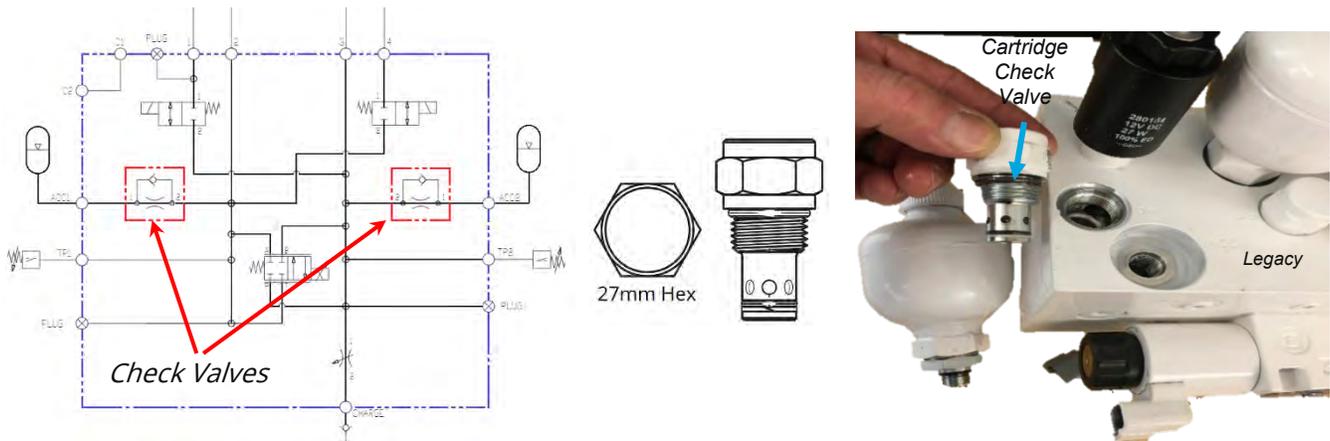
On a bi-directional manifold, check valves are in the oil flow path between the two accumulators and the system (see schematic below). A clogged or faulty check valve will interrupt the normal flow of oil in/out of the accumulators and may cause abnormal precession, accumulator failure or low-pressure alarms.

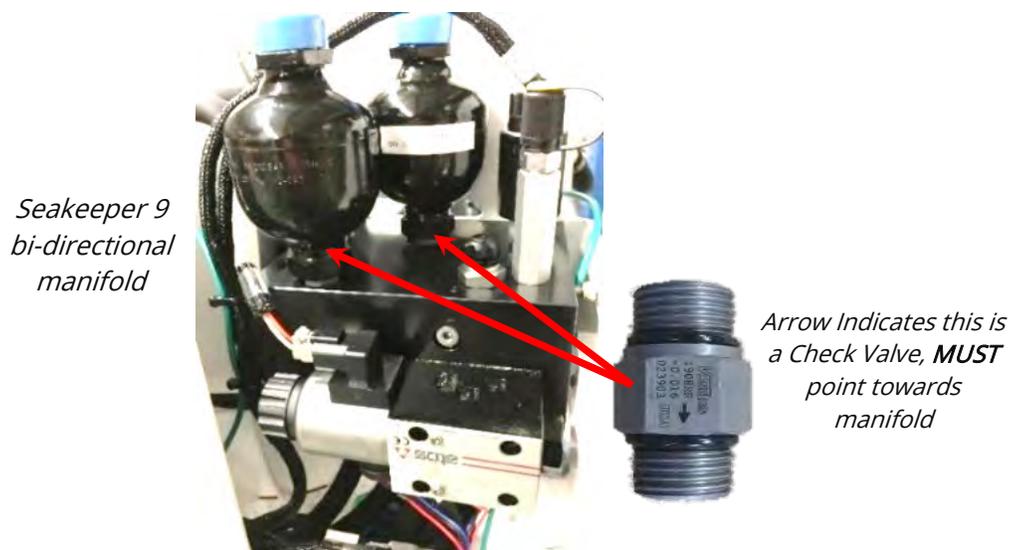
On some models, check valves double as the adapter fittings used to attach accumulators directly to the manifold. They are identifiable by an arrow on their side indicating the free flow path that **MUST** point towards the manifold.

9. **IF** manifold has in-line check valve adapter on accumulators, **THEN VERIFY** both check valves are installed arrows pointing towards manifold.
10. **IF** bi-directional manifold and any of following:
 - When manually precessing sphere forward and aft and brake pressure fluctuates more than 50 psi on pressure gauge attached.
 - When charging brake system from zero pressure and pressure climbs to 200 psi with two pumps of brake service pump.
 - When removing accumulator from a depressurized manifold, there is oil pressure found under accumulator.

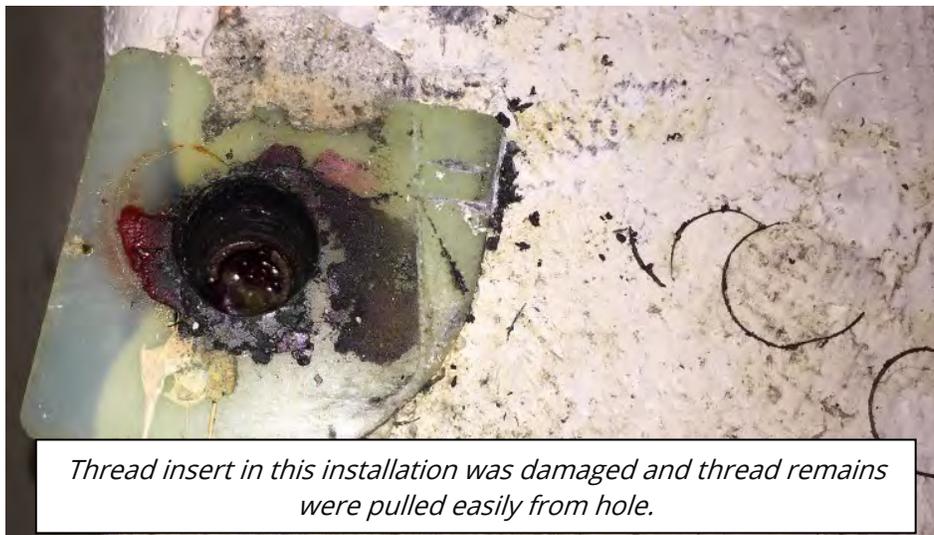
Thread insert in this installation was damaged and thread remains were pulled easily from hole.

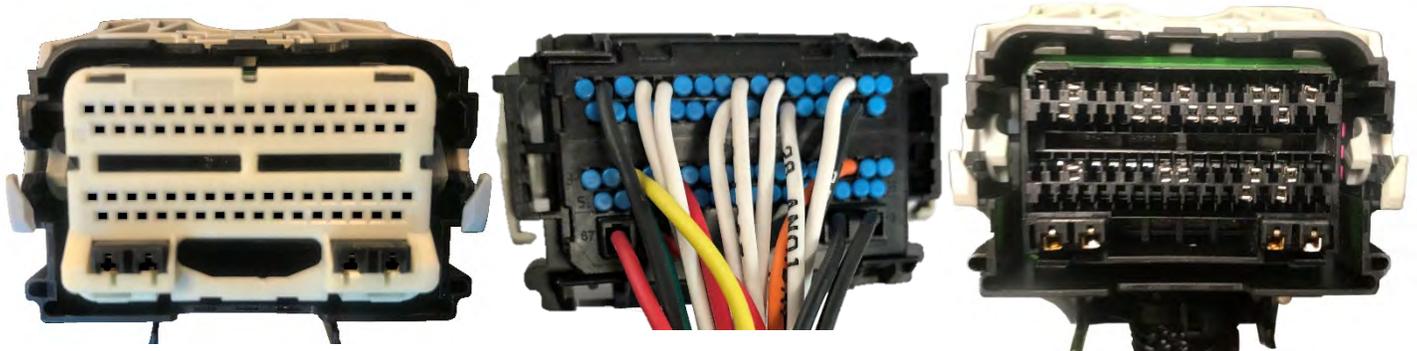
*Properly seated sockets of a
GCM 70-pin connector*
