PRODUCT SEAKEEPER SERIES MODELS

TROUBLESHOOTING GUIDE TABLE OF CONTENTS

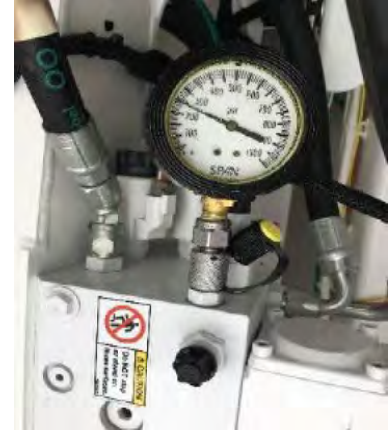
1. **CHECK** hydraulic pressure in Seakeeper brake system as follows:
 - a. **TURN OFF** high current DC/AC power breaker to Seakeeper.
 - b. **ENSURE** Seakeeper flywheel at zero RPM at display/MFD app.
 - c. **ACTIVATE** Brake Override.
 - d. **INSTALL** Seakeeper pressure gauge (P/N 12830) or brake charge hose to brake manifold per [SWI-103 - Seakeeper Brake Service](#) Instruction to determine as-found hydraulic pressure in brake system. [**NOTE:** Do not connect cylinder vents.]
 - e. **MANUALLY PRECESS** enclosure fully forward and aft with Seakeeper still pressurized and watch pressure gauge.
 - i. **NOTE** any pressure spikes of 50 psi or more for later reference.

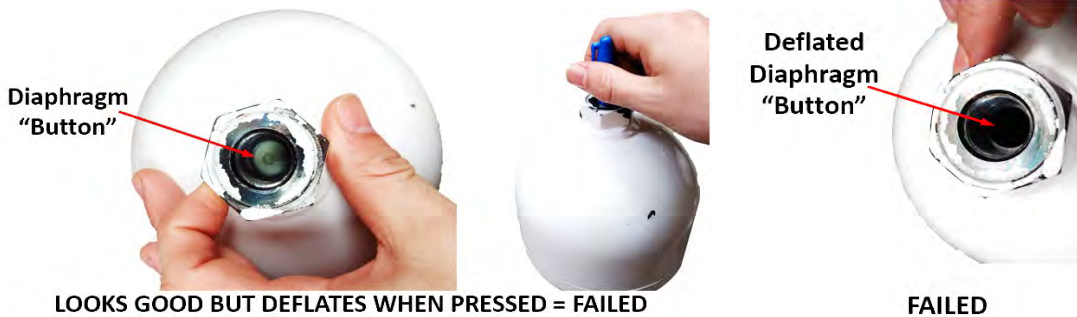
9. With splash-proof goggles/face shield, **TEST** accumulator(s) as follows:

- a. **PRESS** on "button" of diaphragm with a non-sharp tool, such as a marker.
- b. **IF** diaphragm deflates **OR** button can be depressed by hand, **THEN REPLACE** accumulator.
- c. **IF** one accumulator faulty on bi-directional manifold, **THEN REPLACE BOTH** accumulators together.
- d. **IF** diaphragm button remains firm and of sealed construction, **THEN DO NOT REPLACE** accumulator; it has not failed.

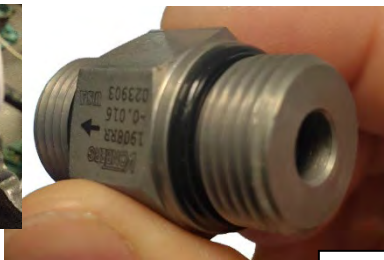
Cartridge type check valve

10. **IF** pressure found when opening bi-directional brake system,
THEN CLEAN OR REPLACE cartridge check valve **OR** check valve adapter.

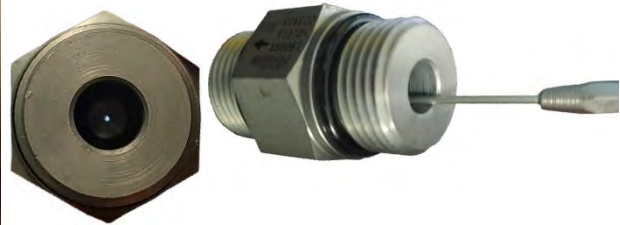
Technician inspecting and cleaning an adapter-type check valve.

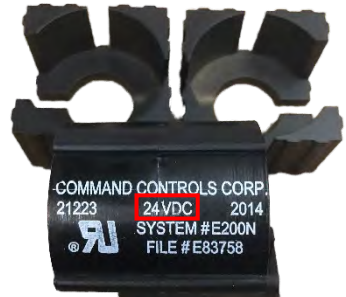
24V coil shown. Replace if found on serial range listed.

THEN REPLACE coil with 28V coil(s) (P/N 50379 or equivalent).

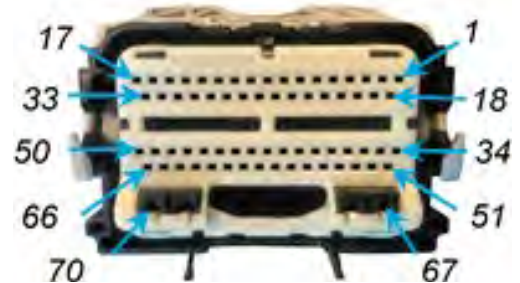
Seakeeper 16/12HD(EM) valve connector

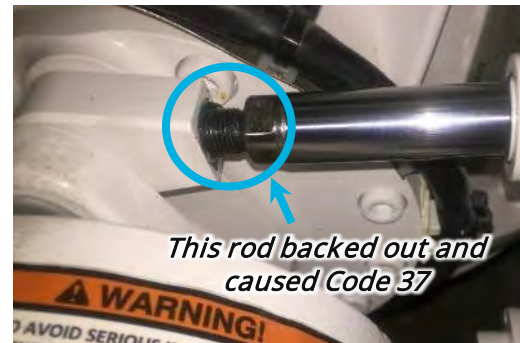
- b. **CHECK** cylinder hose fittings for oil film.
 - c. **CHECK** beneath brake manifold for indication of oil leak and below hose fittings.
4. **CHECK** threads of rod end of each cylinder for threads backing out as shown to right.

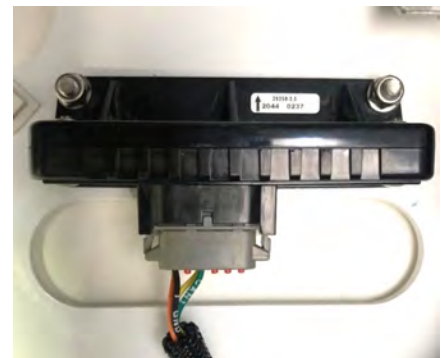
*Seakeeper 18/16 IMU shown
inside rear panel*

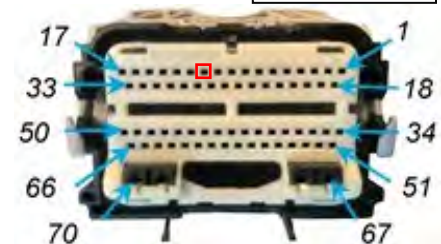
Proportional Valve to GCM Pin-out	
Seakeeper 2, 3, 5, 6/5HD.....	12 Volts
Seakeeper 9/7HD, 16/18/12HD.....	24 Volts
Pin 1 =	12/24v+ from Line 71 (Orange wire)
Pin 2 =	GCM pin 11 (White wire)

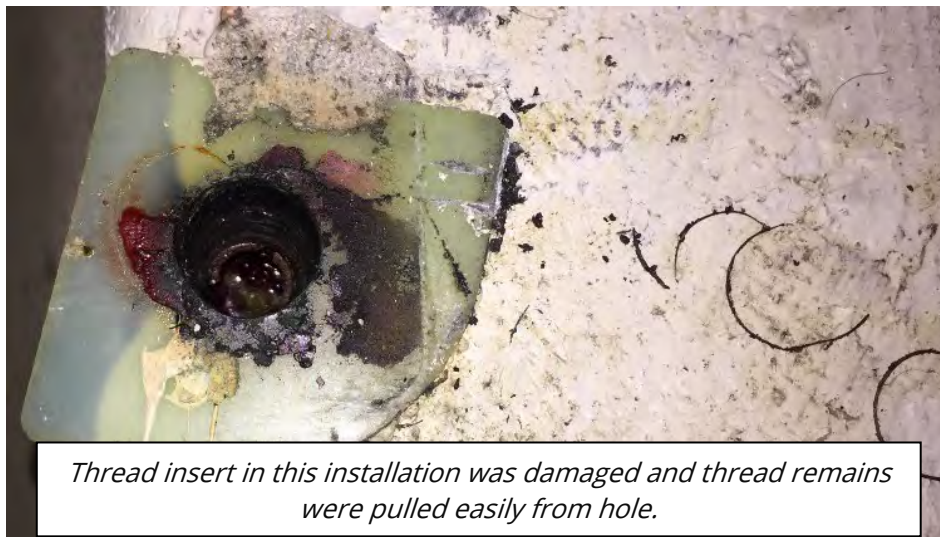
Thread insert in this installation was damaged and thread remains were pulled easily from hole.

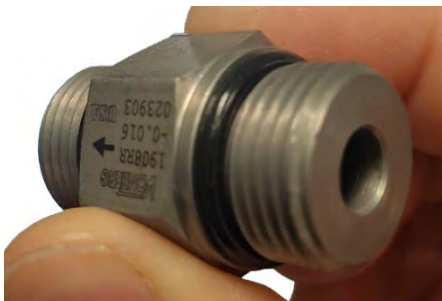
1. **PERFORM** following on Bi-Directional manifolds:
 - a. **CHECK** if accumulators have check valve adapter installed. (Only on AFS bi-directional manifolds)
 - b. **IF** check valve adapters installed, **THEN VERIFY** adapter arrow points toward manifold as shown.
 - c. **INSTALL** brake service kit **AND REMOVE** pressure from brake system.
 - d. **REMOVE** accumulator/check valve adapter assembly.

Should be able to see light through orifice

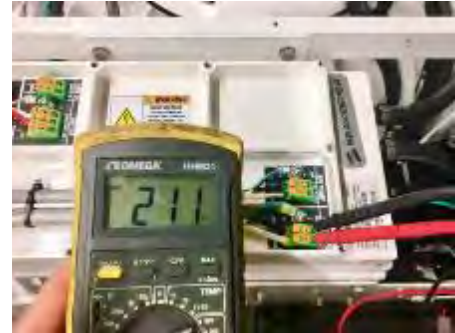
Checking voltage of input power to Seakeeper. Connections beside input line is seawater pump supply.

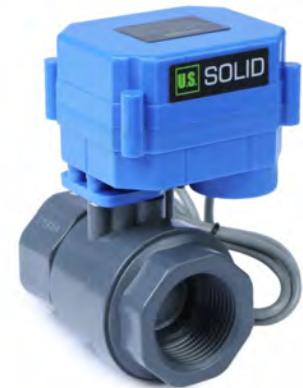
*Electric seawater valve*

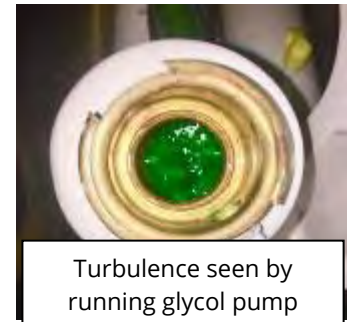
- i. With glycol override still activated, **CONFIRM** voltage between pins **1** and **2** of harness connector to glycol pump by back-probing Deutsch connector.

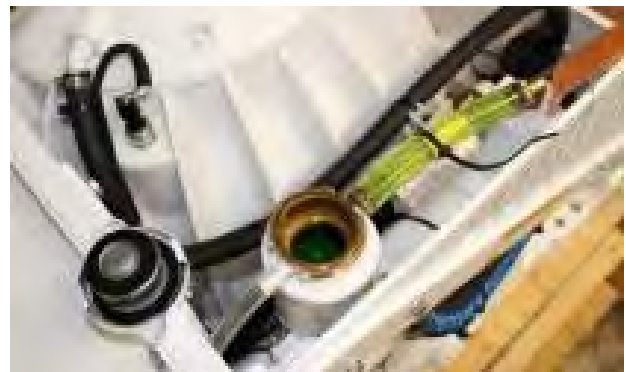
Glycol flow may be seen through fill cap

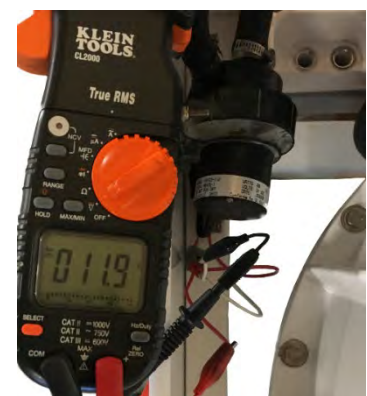
Image of technician back probing glycol pump connector for voltage

e. With multimeter and back-probes, **VERIFY** DC voltage at glycol pump connector within 0.3 volts of DC INPUT voltage.

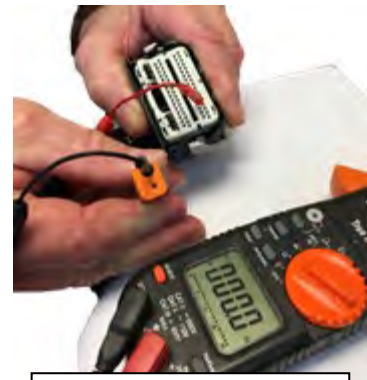
Testing continuity between pin 2 and GCM pin 4 (for Seakeeper 5, 6, or pump 2 on a Seakeeper 35/30HD/40)

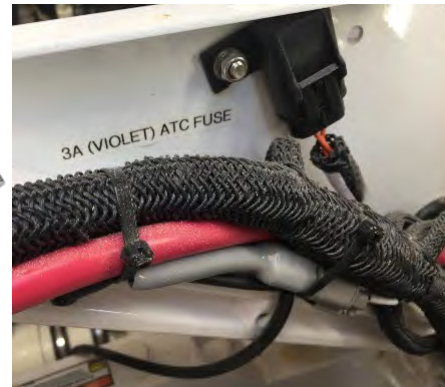
*Example of a blown ATC fuse*

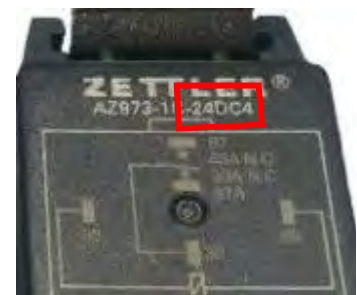
5. **TEST** seawater pump power relay as follows:
 - a. **TURN OFF** DC control power supply breaker.
 - b. **TURN OFF** DC seawater pump supply breaker.
 - c. **VERIFY** nameplate voltage of seawater pump power relay is 12 or 24 VDC rating (as shown in photo).
 - d. **IF** relay voltage marking improper for Seakeeper model, **THEN REPLACE** seawater pump relay with one of proper rating.

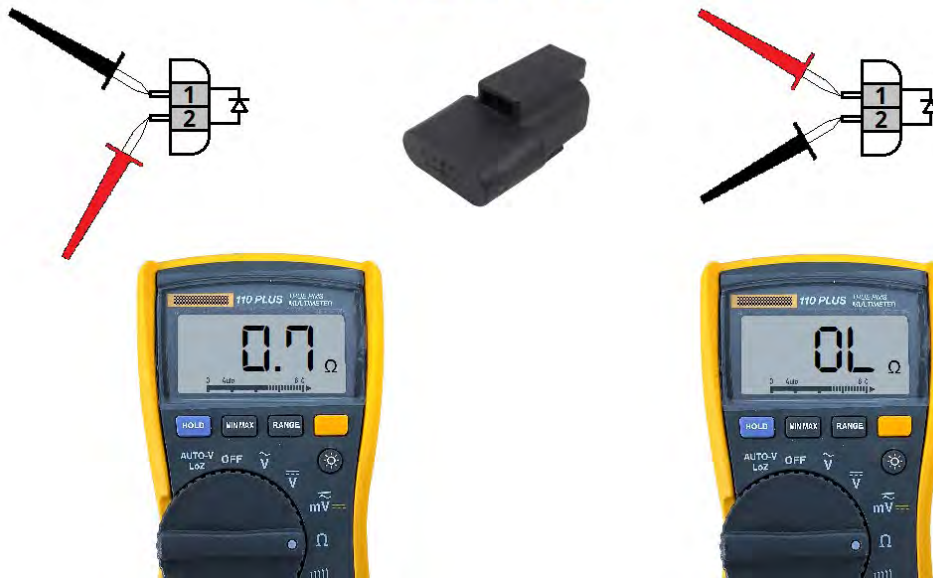
6. **TEST** diode module as follows [**N/A on DC Models**]:**DIODE MODULE**

- a. **UNPLUG** diode module from wire harness.
- b. With multimeter in resistance mode, **TEST** for high (OPEN LOOP) resistance in one direction **AND** 0.5 to 0.8-ohm resistance in other direction on two pins of diode module.
- c. **IF** both resistances measured are high or "OL," **THEN REPLACE** diode module.
- d. **IF** both resistances measured are relatively low (continuity in both directions), **THEN REPLACE** diode module.

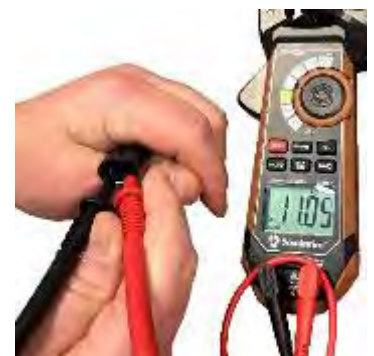
- a. **IF** connection loose, **THEN RECONNECT** any loose connection.
 - b. Momentarily (5 seconds or longer) **CYCLE** DC Control Power to Seakeeper.
 - c. **SPOOL** Seakeeper.
 - d. **VERIFY** all alarms clear.
3. **UNPLUG** affected thermistor from wire harness.
 4. With a multimeter, **VERIFY** resistance between two pins (of sensor) is between 1000Ω and 50,000Ω.

Meter in this photo is displaying 11.05 KΩ.

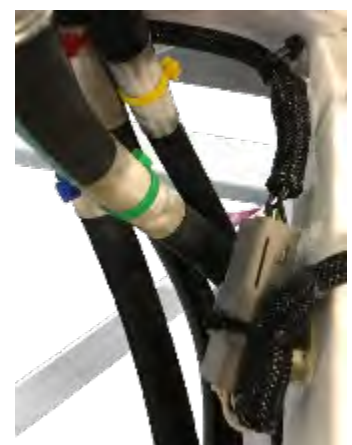
Photo showing location of Guide Band connector inside foundation near guide band bracket and below manifold.

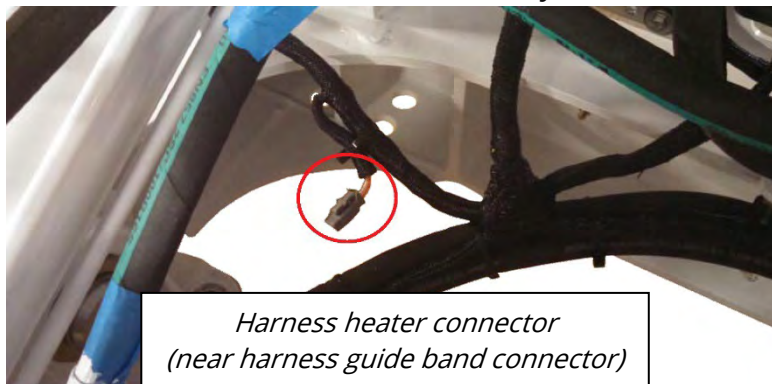
1. **VERIFY** separate 230VAC, 20 amp breaker for heater is **ON** and not tripped.
2. **VERIFY** electrical connections associated with heater assembly are made.
 - a. **IF** unit equipped with heater,
THEN:
 - i. **VERIFY** the heater and harness connectors at right rear of unit (near guide band connector, beneath GCM) is made securely.

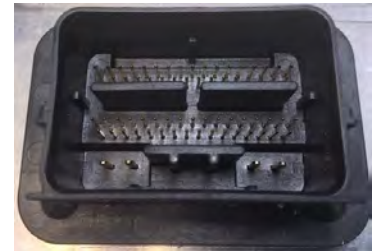
GCM 70-PIN CONNECTOR	MODEL VOLTAGES	
Pin 38: +12V (RED or ORG)	Seakeeper 2 thru 6	12 V
Pin 67: +12V (RED or ORG)	Seakeeper 9 thru 40	24 V
Pin 68: +12V (red or ORG)		
Pin 69: GRND (BLK)		
Pin 70: GRND (BLK)

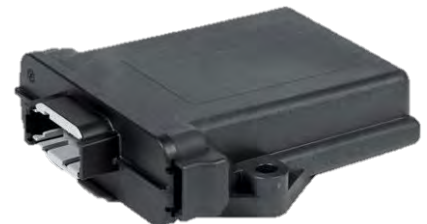
Revision 1 IMU

2. **INSPECT** IMU pins for damaged or bent pins.
3. **IF** revision 1 IMU, **THEN CONTACT** Seakeeper Product Support Team at support@seakeeper.com or emeasupport@seakeeper.com for instructions.
4. **IF** NO loose or damaged pins found, **THEN REPLACE** IMU.
5. **IF** loose pins/crimps found in connector, **THEN REPAIR** pin(s) **OR REPLACE** wire harness.

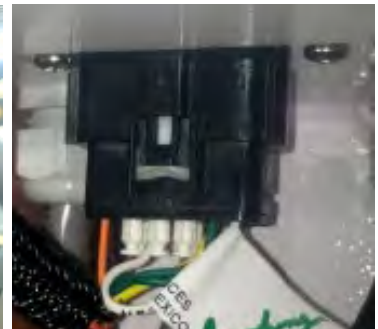
Molex Connector of an AC-powered Seakeeper shown with white locking tab fully inserted

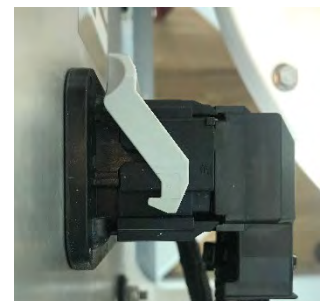
GCM connector fully inserted and locked

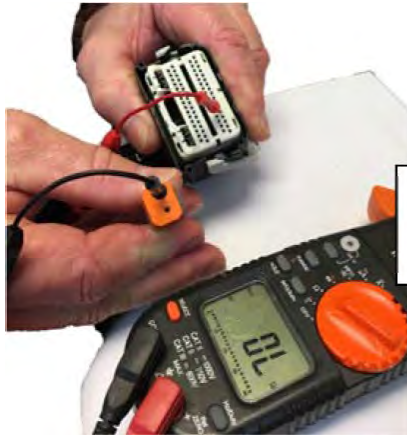
Testing continuity between pin 1 and GCM pin 5 (for Solenoid 1)

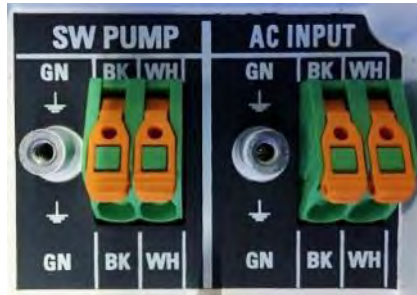
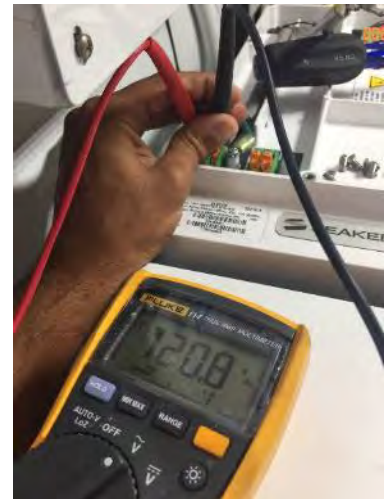
1. With Seakeeper locked and at zero RPM, **REMOVE** MDB cover.
2. **ENSURE** interior of MDB is free of moisture.
3. With a multimeter in “AC Volts” mode, **MEASURE** voltage at “AC INPUT” terminal.

5. **IF** voltage below 80 VAC or above 300 VAC, **THEN TROUBLESHOOT** vessel electrical supply.
6. **VERIFY** leads at “MOTOR” and “AC INPUT” terminals are in correct position by color.
7. **VERIFY** leads are crimped properly, fully inserted into terminal and locked firmly.
8. **IF** any issues found with leads, **THEN CORRECT** issues with motor cable leads.

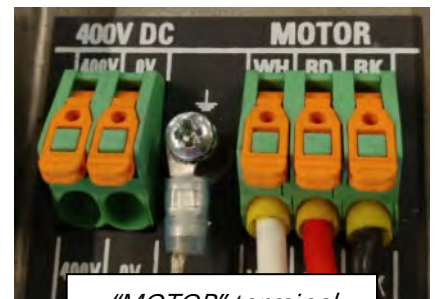
“MOTOR” terminal

crimp of motor cable lead.

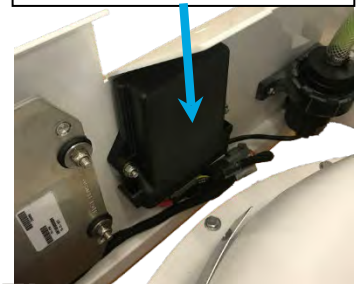
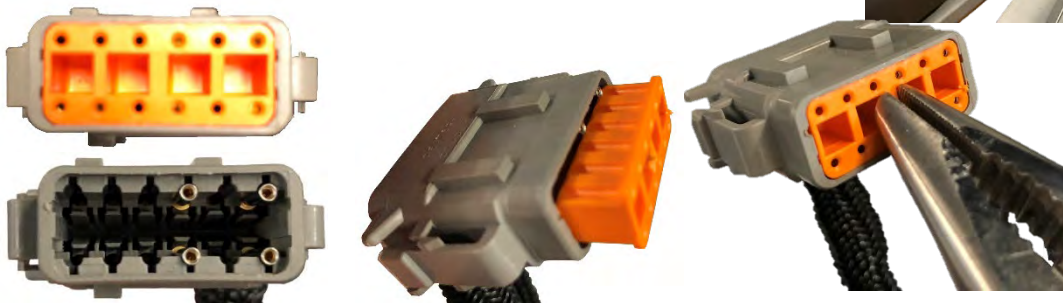
IMU of Seakeeper 3

1. **ENSURE** zero RPM on display or MFD app.
2. **TURN OFF** all breakers to Seakeeper.
3. **DISCONNECT** IMU harness connector.
4. **VISUALLY INSPECT** all wiring and pins of IMU:
 - a. **CUT** cable ties securing harness near IMU, as necessary.
 - b. **INSPECT** wiring near IMU for exposed leads with damage.
 - c. **INSPECT** IMU connector for loose wires or crimps.

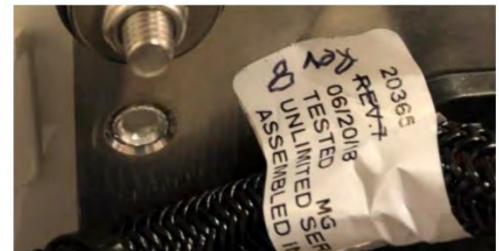
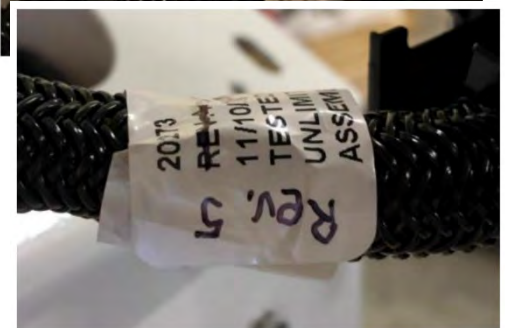
6. **IF** model is Seakeeper 2 or 3,
THEN CHECK following:
 - a. **IF** Seakeeper 2 of S/N 2-0001 through 2-0084,
THEN VERIFY harness label near GCM 70-pin connector reads "REV. 8," or later, as shown.
 - b. **IF** Seakeeper 3 of S/N 3-0001 through 3-0443,
THEN VERIFY harness label near GCM 70-pin connector reads "REV. 5," or later, as shown.
 - c. **IF** appropriate harness tag does not appear as in Steps 6.a or 6.b,
THEN PERFORM harness modification procedure of [SB-90504](#).
 - i. **CYCLE** DC control power.
 - ii. **ATTEMPT** to reset alarm at display/MFD app after modification.

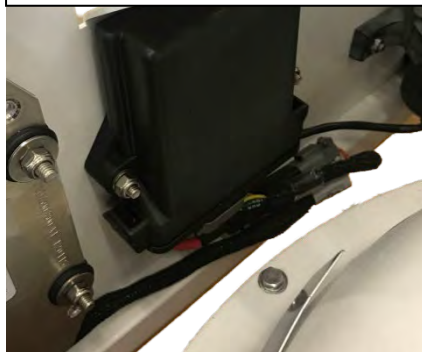
IMU properly installed in a Seakeeper 3

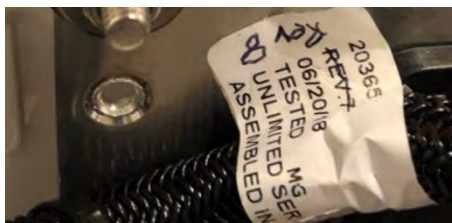
9. **INSPECT** wiring of harness around IMU for signs of damage.
10. **IF** wire harness appears damaged, **THEN REPLACE** wire harness.
11. **CYCLE** DC power to test alarm clear.
12. **IF** Seakeeper 2 or 3 model, **THEN PERFORM** following:
 - a. At GCM connection of wire harness (near front panel), **CHECK** tag for revision of harness.

Seakeeper 2 harness should be Rev. 8 or later.

- b. **IF** harness revision is before “REV. 8” for Seakeeper 2 or “REV. 5” for Seakeeper 3, **THEN PERFORM** harness modification per [SB-90504](#).

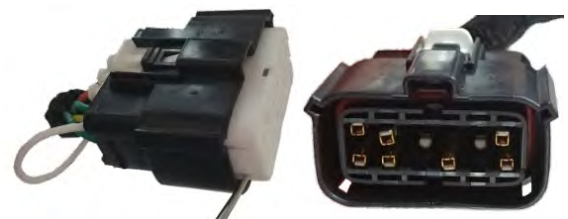
REARVIEW OF HARNESS CONNECTOR			
Wire Color/Description	Pin No.	Pin No.	Wire Color/Description
Orange (+12/24VDC)	1	12	Green (CAN1-)
PLUG	2	11	Yellow (CAN1+, Ckt 36)
PLUG	3	10	PLUG
PLUG	4	9	White (Gnd) jumper w/ pin 6
Green (CAN1-)	5	8	PLUG
White (Gnd) jumper w/ pin 9	6	7	Black (Gnd)

3. **REMOVE** white cover of connector.
4. **CONFIRM** pins are inserted, as shown.
5. **TUG** on wires from back to ensure pin-to-wire crimps are secure **AND** pins locked into connector.
6. **IF** issues found in MDB connector, **THEN CONTACT** Seakeeper Product Support Team at support@seakeeper.com or emeasupport@seakeeper.com for repair guidance.
7. **DISCONNECT** GCM 70-pin connector.

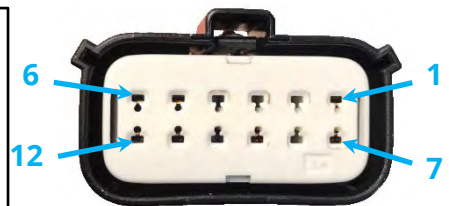
AC-powered Seakeeper
MDB Molex Connector

- 1: 12/24 VDC, ORG
- 2-4, 8 & 10: PLUG
- 5: CAN-, GRN
- 6: Jumper w/ 9, WHT
- 7: GND, BLK
- 9: Jumper w/ 6, WHT
- 11: CAN+, YEL
- 12: CAN-, GRN

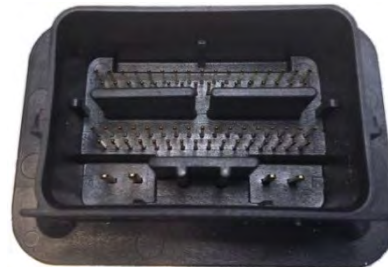
GCM pins

- i. **IF** pin(s) found bent,
THEN REPAIR pin(s).
9. **TURN ON** DC control power breaker to Seakeeper.
10. **MEASURE** for DC input voltage present between pin **1** and pin **7** of motor drive (Molex) connector.

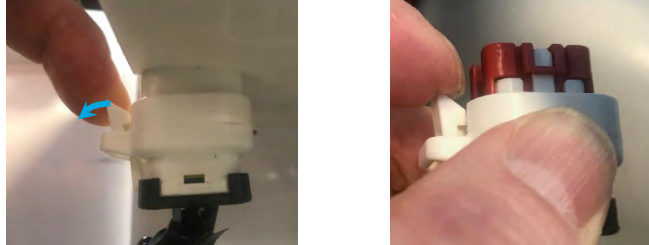
1. With all Seakeeper power removed, **DISCONNECT** MDB connector as follows:

- a. **PULL OUT** locking wedge tab.
 - b. While pulling out on lock wedge tab, **PULL DOWN** on connector from MDB.
2. **VERIFY** connector wiring per table below:

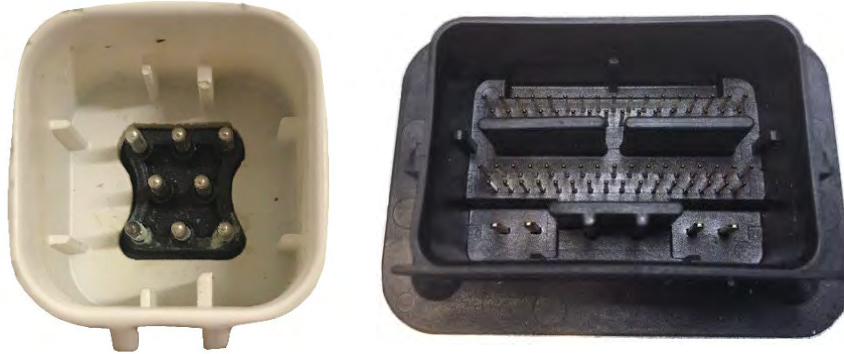
8. **INSPECT** for damage to pins of MDB and GCM.

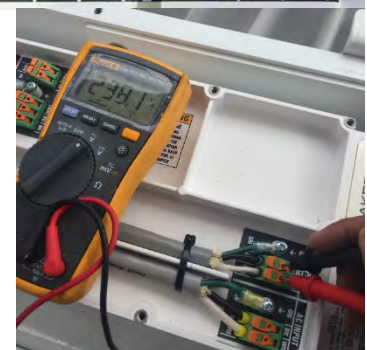
Testing SW Pump voltage

9. At display/MFD app, **ACTIVATE** SW Pump Override.
10. **CONFIRM** voltage at “SW PUMP” terminal is same as “AC INPUT” voltage.
11. **IF** seawater pump fails to operate, **THEN REMOVE AND BENCH TEST** seawater pump to verify pump operable.
- a. **IF** seawater pump motor failed, **THEN CONTINUE** in procedure.
12. **DEACTIVATE** SW Pump Override.
13. **TURN OFF** AC breaker to Seakeeper.

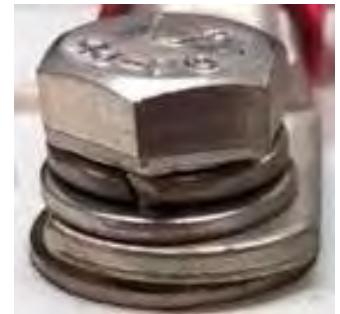
11. **RE-ATTACH** all motor cable leads to respective terminal.
12. **TORQUE** terminal leads per [Torque Specifications](#) section.
 - a. **ENSURE** lock washers are flattened after torquing as shown.
13. **INSTALL** cover at motor drive cable contact posts and High DC current input terminals.
14. **TURN ON** all Seakeeper breakers.
15. **IF** issue persists,
THEN CONTINUE to Section 3 (next page).

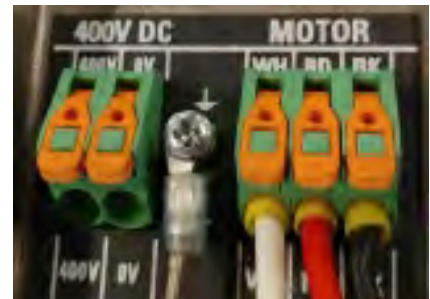
1. **ENSURE** flywheel at zero RPM at display or MFD app.
2. **TURN OFF** AC breaker to Seakeeper.
3. **REMOVE** MDB cover to expose "MOTOR" lead connections for following checks:
 - a. **SAVE** all ten M4 cover screws in safe place.
 - b. **INSPECT** crimps at end of each motor cable lead to ensure they are in good condition.
 - c. **LOOSEN** MDB feed-through grommet **AND EXAMINE** motor drive cable insulation at grommet for damage.
4. **ENSURE** interior of MDB is free of moisture.
5. **TURN ON** AC breaker to Seakeeper.
6. With multimeter on AC Volts, **TEST** voltage at AC INPUT terminal per Table 1.

TABLE 1: VOLTAGES FOR MODELS		
MODEL	AC VOLTAGE	DC VOLTAGE
Seakeeper 5 (EM), 6 or 5	97.2 - 132, or 188 - 264	12
Seakeeper 9/7HD through 40	188 - 264	24

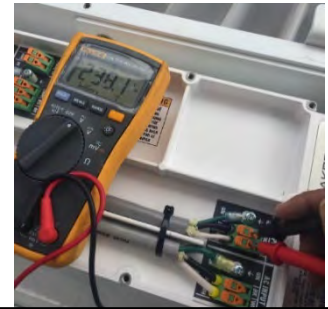
*Testing SW Pump
voltage*

Voltage at SW PUMP terminal: _____ **VAC**

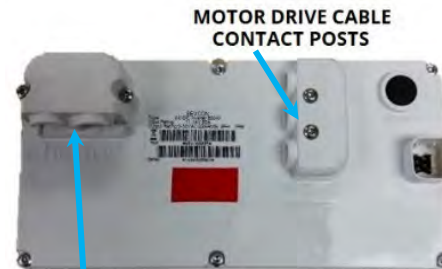
SEAKEEPER 2 & 3 MDB (BOTTOM VIEW)

MDB Ground to foundation *Motor Frame Ground to MDB*

HIGH DC CURRENT INPUT

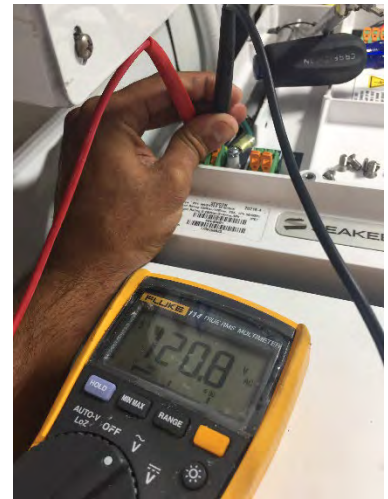
- b. **MEASURE** voltage at "AC INPUT" terminal.

- c. **IF** voltage not between 80 and 300 VAC,
THEN TROUBLESHOOT AC power cable to Seakeeper.
 - d. **DOCUMENT** voltage and source.

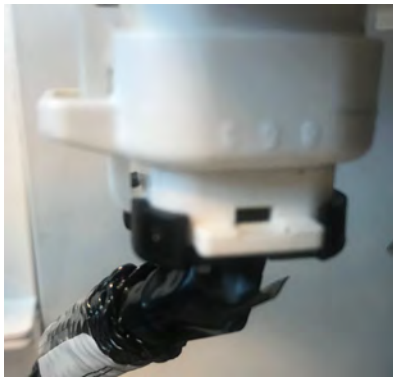
2. **ENSURE** flywheel at zero RPM at display or MFD app.
3. **TURN OFF** all Seakeeper power breakers.
4. **VERIFY** wire harness connector at Motor Drive is fully inserted.

Photo shows Connector Position Assurance (CPA) device fully inserted on an AC-powered

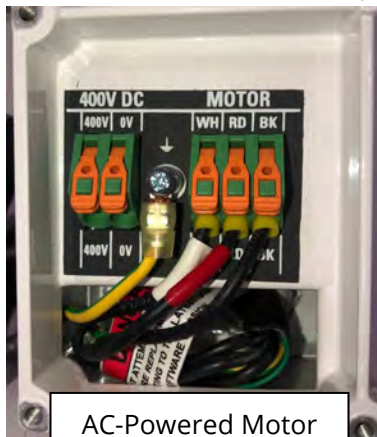
AC-Powered Motor terminals

5. **VERIFY** motor terminal leads securely attached.

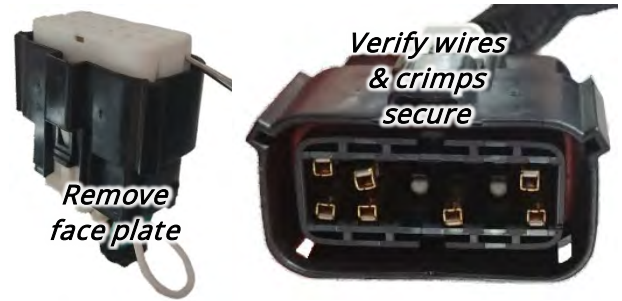
2. **IF** MDB version XXXXX-3 or older (as seen in photo), **THEN:**

- a. **IF** MDB revision 2, **THEN:**
 - i. **REPLACE** MDB.
 - ii. **CONTINUE** in procedure.
- b. **TURN OFF** AC breaker to Seakeeper.
- c. **OPEN** MDB cover.
- d. **INSPECT** for metallic wire bushing in grommet of motor power cable.
- e. **IF** bushing present, **THEN:**
 - i. **DISCONNECT** motor power wires from MDB terminal.
 - ii. **REMOVE** bushing from grommet.
 - iii. **APPLY** heat shrink shroud around cable at grommet.
 - iv. **RECONNECT** motor power cable wires to MDB terminal.

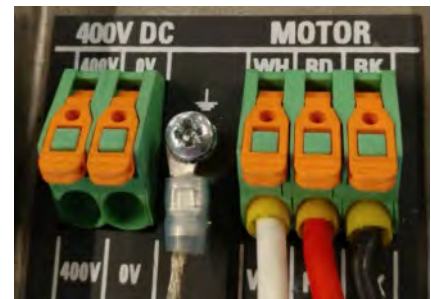
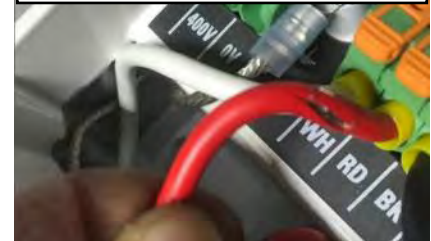
This damaged insulation caused DSPPF Fault in this Seakeeper.

15. **LOOSEN** MDB feed-through grommet.
16. **EXAMINE** motor drive cable insulation at grommet.
- a. **DOCUMENT** any damage found on cable insulation.

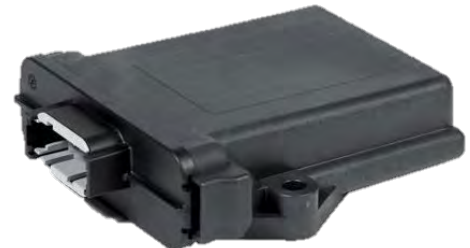
*Revision 1 IMU*

9. **IF** component software (MDB, IMU or GCM) is found incompatible, **THEN REPLACE** applicable component as follows:
- a. **IF** Code 108 or Code 109, **THEN REPLACE** MDB.
 - b. **IF** Code 110, **THEN REPLACE** IMU.
 - i. **IF** revision 1 IMU (large IMU case), **THEN CONTACT** Seakeeper Product Support Team at support@seakeeper.com or emeasupport@seakeeper.com for instructions.
 - c. **IF** code 252 (despite alarm clearing by cycling power), **THEN VERIFY** display cable does **NOT** run near other higher current carrying cables or devices.
 - d. **IF** code 252 **AND** 3.5" display is fitted, **THEN PERFORM** following:
 - i. **INSPECT** cable at back of display for any connection to display cable "SHIP MONITOR" pigtail.

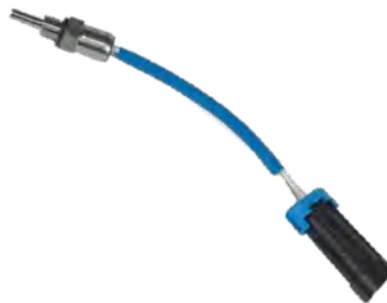
Harness connector to thermistor

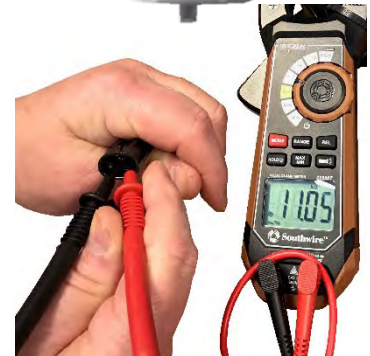
Meter in this photo is displaying 11.05 KΩ.

- a. **IF** resistance is higher than 50,000Ω **OR** less than 1000Ω, **THEN REPLACE** bearing thermistor.
 - b. **CYCLE** DC control power to Seakeeper **AND CHECK** all display codes clear.
7. **REMOVE AND SWAP** effected thermistor with opposite thermistor's harness connection.

Resistance vs. Temperature			
Temperature °C / °F	Resistance (Ω)	Resistance Tolerance	Tolerance ±°C / °F
25 / 77	10,000	5.00	1.14 / 2
85 / 185	1070	6.77	2.15 / 4

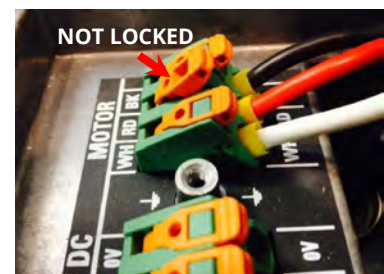
- a. **IF** terminal block orange tab will not lock (as shown to right), **THEN:**
 - i. **ROTATE** crimp.
 - ii. **RELOCK** crimped lead.

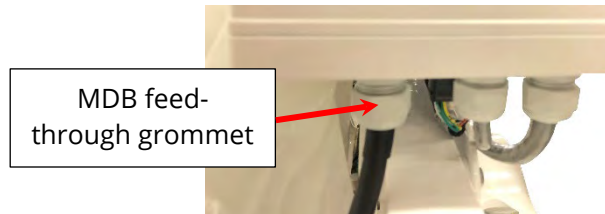
8. **PERFORM** following at motor drive:
 - a. **LOOSEN** MDB feed-through grommet.

- b. **EXAMINE** motor drive cable insulation at grommet.
 - c. **IF** insulation damage found **THEN CONTACT** Seakeeper Product Support Team at support@seakeeper.com or emeasupport@seakeeper.com.
9. **TURN ON** AC power supply breaker to Seakeeper.
10. With multimeter in AC Volts mode, **MEASURE** voltage at "AC INPUT" terminal between black and white terminals.

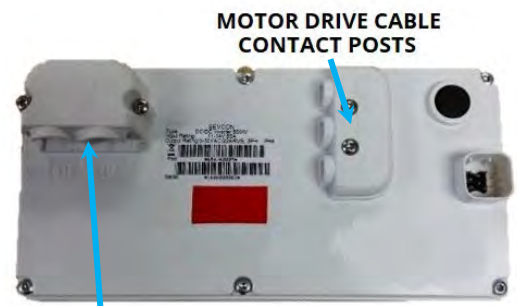
**SEAKEEPER 2 & 3 MDB
(BOTTOM VIEW)**

1. **ENSURE** flywheel at zero RPM at display or MFD app.
2. **TURN OFF** all power to Seakeeper.
3. **REMOVE** cover at motor drive contact posts and High DC input terminals. (T20 Torx bit)
4. **INSPECT** for severe corrosion at contacts or damage to cables.
5. **VERIFY** terminal leads torqued per [Torque Specifications](#) section **AND** motor cable leads in correct color location.
6. **TURN ON** high-current DC power breaker to Seakeeper.
7. **MEASURE** high DC voltage at INPUT terminals. [NOTE: Voltage should be 11.2 to 15.0VDC.]

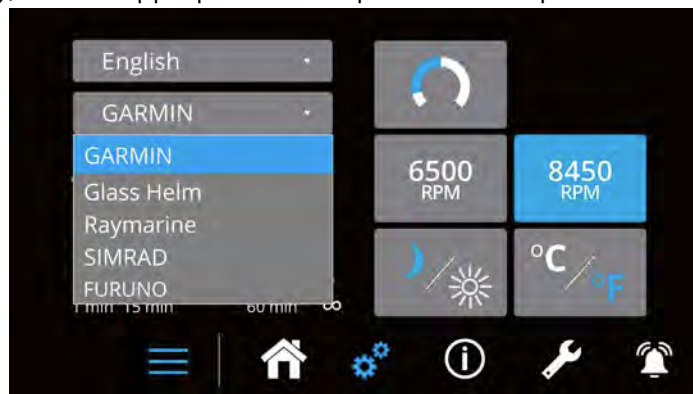
5. Using appropriate MFD Compatibility Technical Bulletin referenced, **ENSURE** ConnectBox or 5" display is correctly synchronized with MFD device.
 - a. On 5" Display, **SELECT** appropriate MFD option from dropdown list on Settings page.

Pressing and holding Settings button

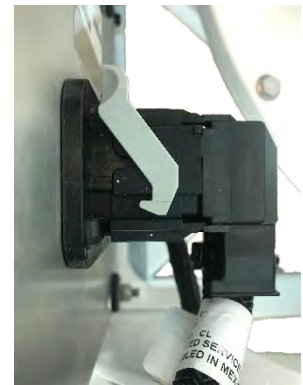
This Seakeeper 6 was installed with "BRAKE VALVE" connector in "SOLENOID 1" connection, resulting in multiple travel faults and Code 50 and 55 errors.

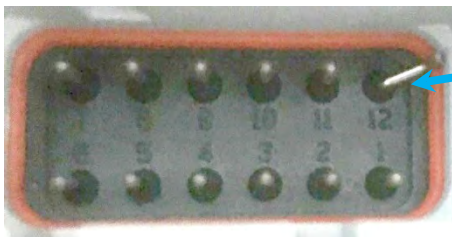
This damaged IMU pin prevented proper seating of harness connector.

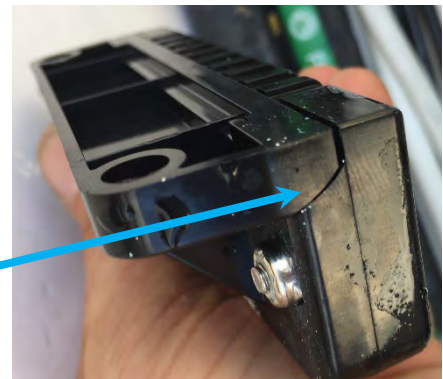
This damaged IMU housing allowed water intrusion.

5. **IF** water intrusion found, **THEN INSPECT** other connectors (GCM 70-pin connector and MDB harness connector) of Seakeeper for water.
6. **IF** water intrusion found, **THEN REPLACE** wire harness.

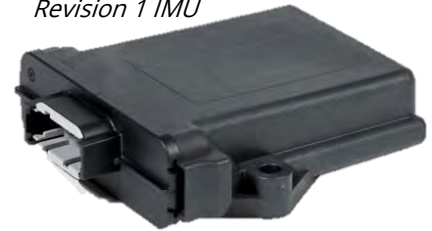
Revision 1 IMU

11. **IF** alarm persists **AND** IMU was not replaced previously, **THEN REPLACE** IMU.
- a. **IF** replacing revision 1 IMU, **THEN CONTACT** Seakeeper Product Support Team at support@seakeeper.com or emeasupport@seakeeper.com for instructions.

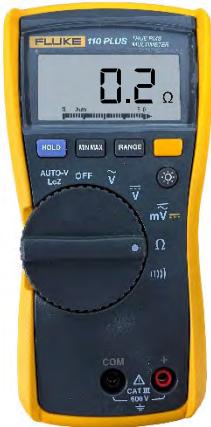
EARLY SEAKEEPER 9 HARNESS EXAMPLE

Vacuum Sensor connections

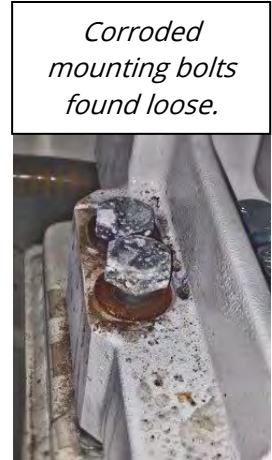
Milky appearance in this bleed line indicates gases in hydraulic fluid that must be completely bled.
 - d. **IF** gases found in fluid, **THEN COMPLETELY** bleed brake system per [SWI-103](#).
 - e. **PRESSURIZE** brake system per [SWI-103](#).
9. **DEACTIVATE** brake override.

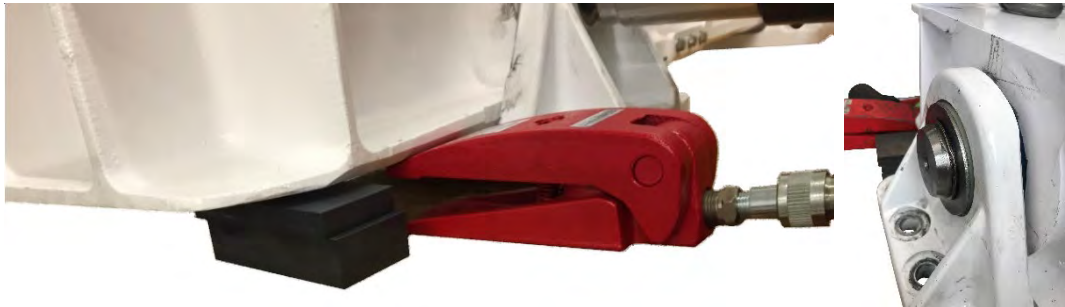
1. **REPLACE** isolation bushings per [SWI-125 - Seakeeper Isolation Bushing Service](#).

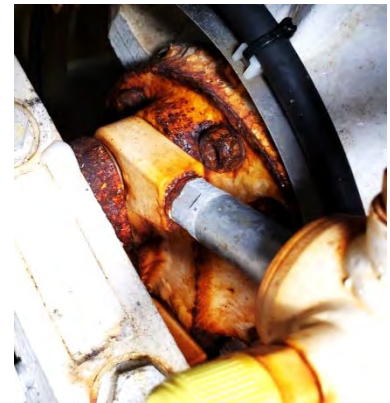
Seakeeper 3 with severe corrosion at rod end clevises, pins, and gimbal shafts

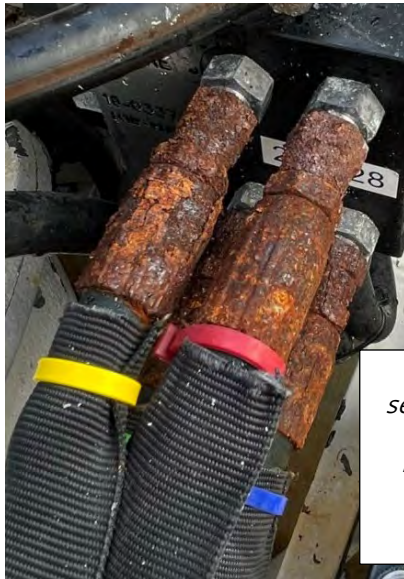
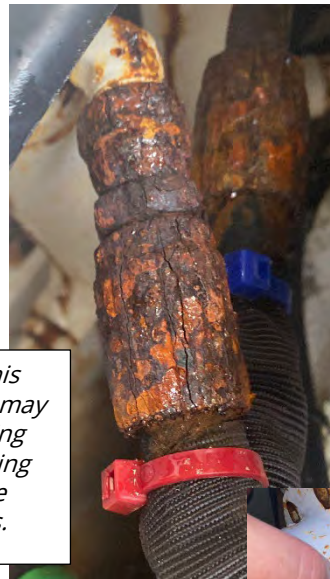
With corrosion this severe, restoration may be futile in stopping leaks and preventing future low brake pressure alarms.

1. **ENSURE** flywheel at zero RPM at display or MFD app.
2. **DEENERGIZE** all power to Seakeeper.
3. **REMOVE** top cover panels from Seakeeper.
4. **REPLACE** components that are corroded beyond reasonable restoration.
 - a. **IF** multiple components corroded beyond restoration, **THEN CONTACT** Seakeeper Product Support Team at support@seakeeper.com or emeasupport@seakeeper.com to consider other options.
 - b. **IF** brake hose fittings are severely corroded, **THEN REPLACE** brake hoses.

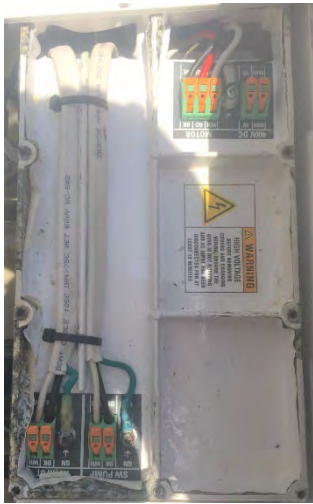
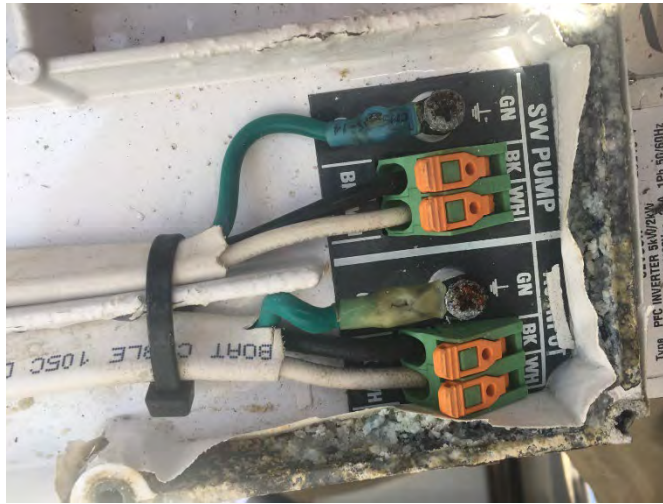
- d. **IF** indication of corrosion at an AC-powered Seakeeper Motor Drive, **THEN:**
- i. **REMOVE** Motor Drive cover.
 - ii. **INSPECT** drive internal surfaces.
 - iii. **IF** any evidence of corrosion or moisture intrusion present, **THEN REPLACE** motor drive per [SWI-094](#).

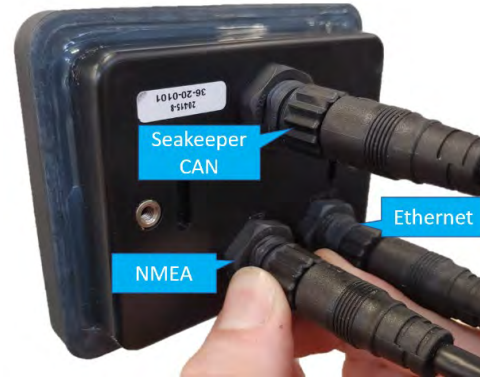
*ConnectBox requires a SOG signal from NMEA network*

7. For ConnectBox, **ENSURE** NMEA2000 connection at correct location.
8. **PERFORM** sea trial:
- a. **SET-UP** Seakeeper Service Tool app to run data log for sea trial per [SWI-118](#).
