**TROUBLESHOOTING GUIDE TABLE OF CONTENTS**

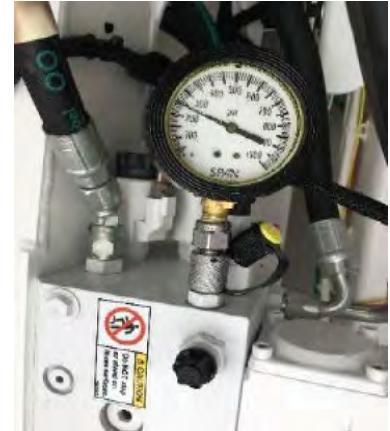
1. **CHECK** hydraulic pressure in Seakeeper brake system as follows:
  - a. **TURN OFF** high current DC/AC power breaker to Seakeeper.
  - b. **ENSURE** Seakeeper flywheel at zero RPM at display/MFD app.
  - c. **ACTIVATE** Brake Override.
  - d. **INSTALL** Seakeeper pressure gauge (P/N 12830) or brake charge hose to brake manifold per [SWI-103 - Seakeeper Brake Service](#) Instruction to determine as-found hydraulic pressure in brake system. [**NOTE:** Do not connect cylinder vents.]
  - e. **MANUALLY PRECESS** enclosure fully forward and aft with Seakeeper still pressurized and watch pressure gauge.
    - i. **NOTE** any pressure spikes of 50 psi or more for later reference.

Brake pressure can fluctuate. Causes can be such as cooling or warming of the hydraulic oil due to use or lack of use, ambient temperatures, extreme low temperatures, etc.

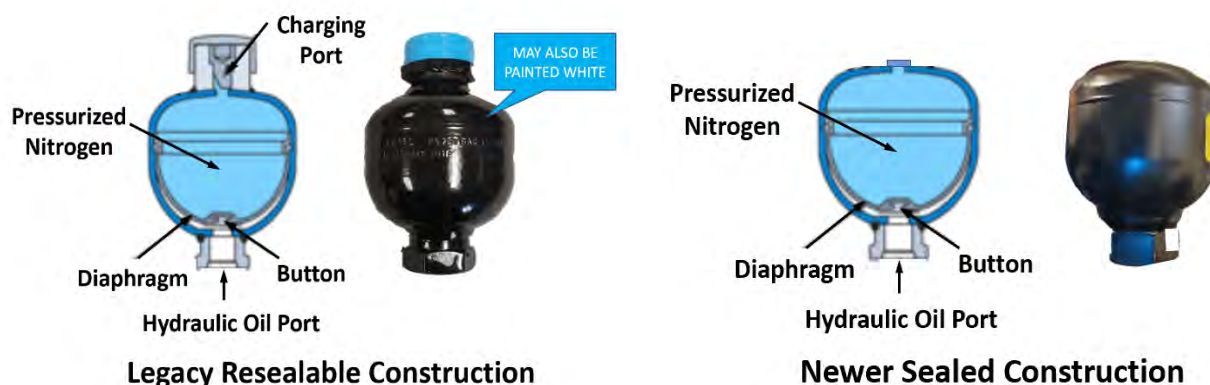
An Accumulator diaphragm can fail and allow nitrogen and oil to mix. When looking in the hydraulic oil port of an accumulator the plastic "button" of the diaphragm should be visibly pressed up against the opening. If the diaphragm has failed it will often deflate entirely within the accumulator, but may not, due to being filled with oil.

A legacy resealable accumulator may also commonly fail due to nitrogen leaking out of its resealable charging port. All or some of the nitrogen pressure may be lost impacting performance. The nitrogen cannot be recharged in the field.

- a. **PRESS** on "button" of diaphragm with a non-sharp tool, such as a marker.
- b. **IF** diaphragm deflates **OR** button can be depressed by hand,  
**THEN REPLACE** accumulator.
- c. **IF** one accumulator faulty on bi-directional manifold,  
**THEN REPLACE BOTH** accumulators together.
- d. **IF** diaphragm button remains firm and of sealed construction,  
**THEN DO NOT REPLACE** accumulator; it has not failed.

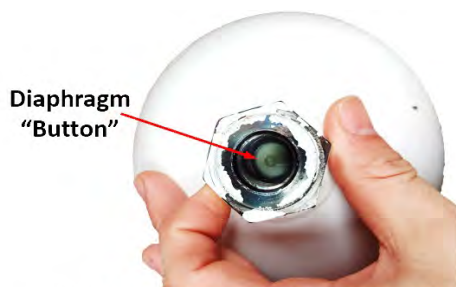
LOOKS GOOD BUT DEFLATES WHEN PRESSED = FAILED

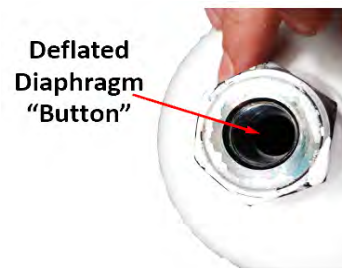
FAILED

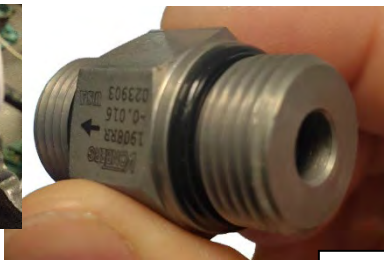
*Cartridge type  
check valve*

10. **IF** pressure found when opening bi-directional brake system,  
**THEN CLEAN OR REPLACE** cartridge check valve **OR** check valve adapter.

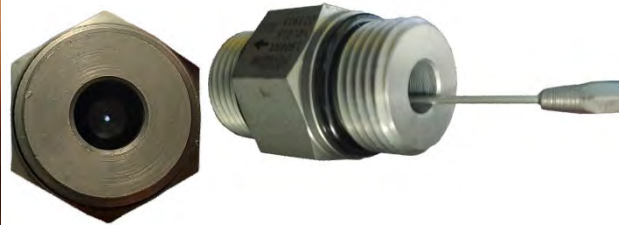
*Technician inspecting and cleaning an  
adapter-type check valve.*

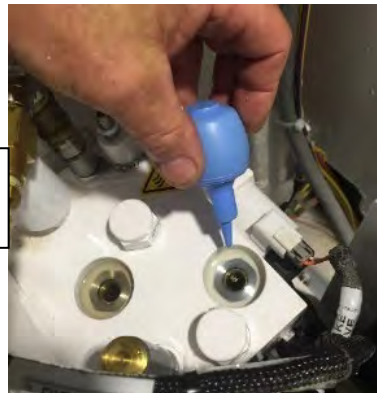
*Bulb aspirator removing  
excess oil or debris in cavity.*

11. **USE** bulb aspirator to draw out any debris or excess oil from manifold cavities.

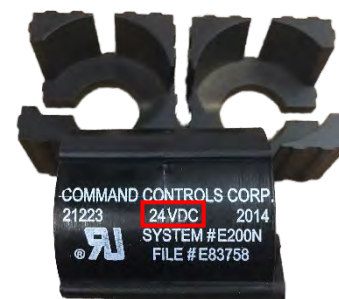
*24V coil shown.  
Replace if found on  
serial range listed.*

**THEN REPLACE** coil with 28V coil(s) (P/N 50379 or equivalent).

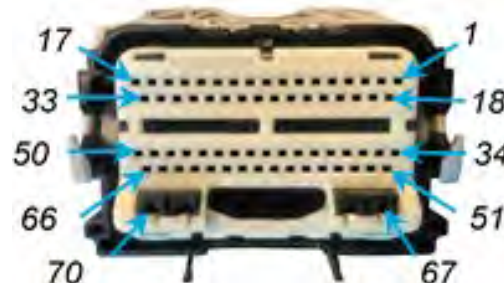
Seakeeper  
16/12HD(EM) valve  
connector

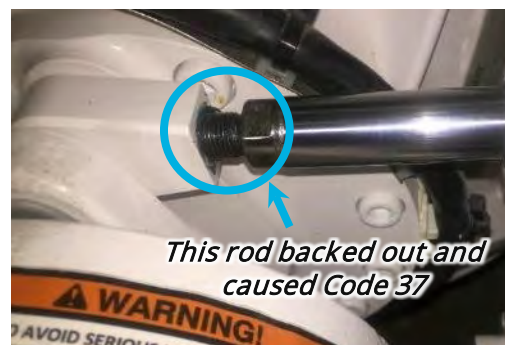
- b. **CHECK** cylinder hose fittings for oil film.
  - c. **CHECK** beneath brake manifold for indication of oil leak and below hose fittings.
4. **CHECK** threads of rod end of each cylinder for threads backing out as shown to right.

- b. **IF** any manifold or hose fitting leak was found in Step 3.b or 3.c,  
**THEN PROCEED** to [Section 2](#).
  - c. **IF** threads were backing out in Step 4 **OR** misalignment found **OR** issues in cylinders while precessing in Step 7, **OR** gimbal shaft screw torque marks not aligned in Step 5,

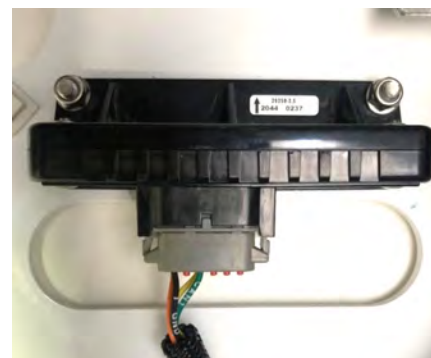
*Seakeeper 18/16 IMU shown  
inside rear panel*

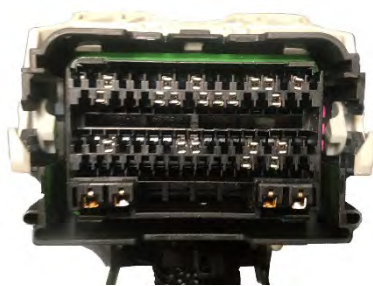
*GCM 70-pin  
connector with face  
plate removed*

4. **IF** associated connector(s) corroded,  
**THEN CLEAN** connectors with contact cleaner and/or wipe all corrosion with clean rag.
5. **IF** angle sensor wiring affected,  
**THEN PERFORM** [Section 4, Step 4](#) tests of wire harness and sensor leads.

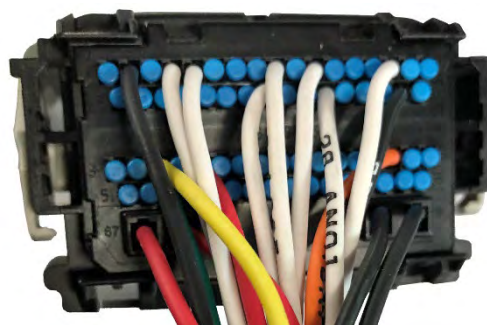
*IMU connector*

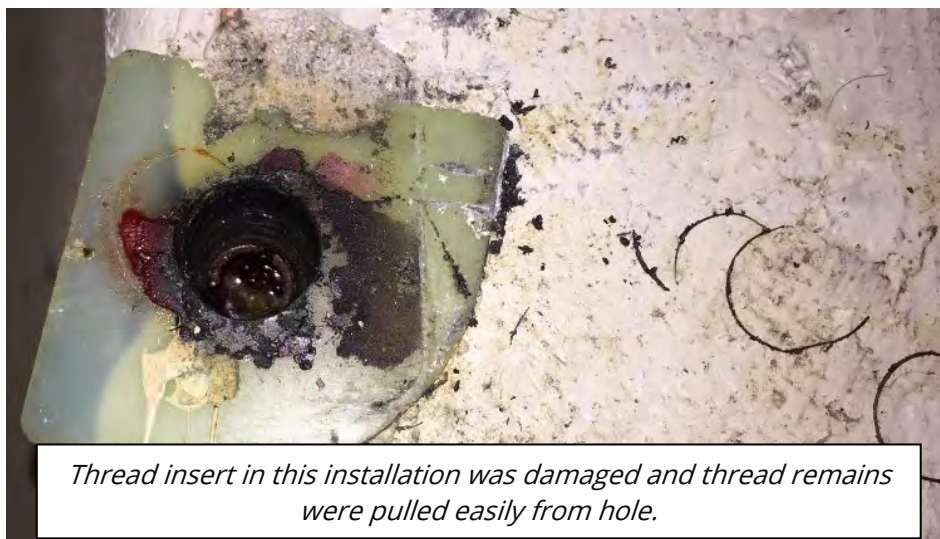
*Thread insert in this installation was damaged and thread remains were pulled easily from hole.*

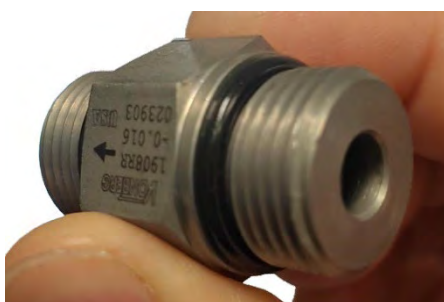
*Should be able to see light through orifice*

- e. **INSPECT** check valve adapter for clear passages **AND** proper operation.
  - f. **REINSTALL** accumulator/check valve adapter assembly.
  - g. **THOROUGHLY VENT** brake system per [SWI-103](#).
  - h. **REPRESSURIZE** brake system.
2. **IF** submitted photo of Information screen showed improper software versions (from Section 5, Step 9), **THEN REPROGRAM / REPLACE** GCM.
3. **IF** GCM recently reprogrammed or replaced, **THEN CONTACT** Seakeeper Product Support Team. [proportional valves require pairing with GCM]
4. **PERFORM** sea trial **AND LOG** CAN data using Seakeeper Service Tool per [SWI-118](#).
5. **IF** alarm persists, **THEN SUBMIT** all test results data and photos from complete troubleshooting to Seakeeper Product Support Team at support@seakeeper.com or emeasupport@seakeeper.com.

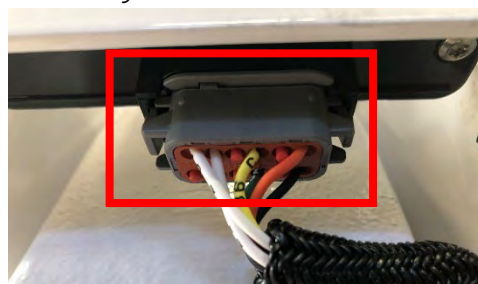
A properly  
connected  
GCM 70-pin  
connector

Fully seated IMU connector

3. **IF** Seakeeper 26/20HD, 35/30HD or 40,  
**THEN CHECK** connection at IMU.
4. **CHECK** labels of harness connectors correspond to appropriate devices.

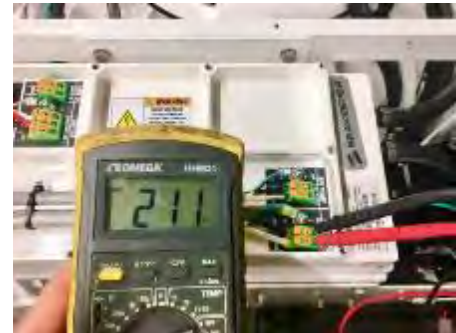
*Checking voltage of input power to Seakeeper. Connections beside input line is seawater pump supply.*

- viii. **DEACTIVATE** seawater override.
- ix. **REINSERT** seawater pump leads at SW PUMP terminal.
- x. **ACTIVATE** seawater override.
- xi. **TEST** for voltage at seawater pump motor.
- xii. **IF** voltage NOT present at pump motor but was present at SW PUMP terminal in Step 3.b.vii,  
**THEN TEST** continuity of seawater pump cable.
- xiii. **IF** continuity NOT present,  
**THEN REPLACE** seawater pump cable.
- xiv. **IF** both locations show proper voltage,  
**THEN REPLACE** Seawater Pump.
- xv. **IF** voltage is not present at MDB SW PUMP posts **OR** is much lower than AC INPUT terminal voltage,  
**THEN REPLACE** MDB.

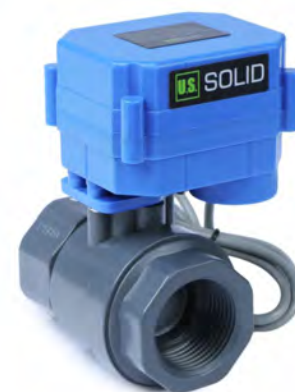
*Electric seawater valve*

- g. **CLOSE** electric ball valve if opened manually.

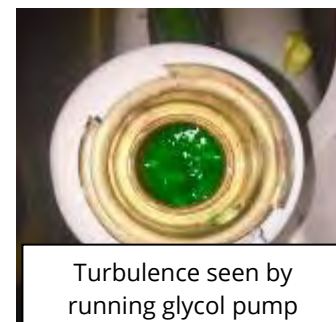
- i. With glycol override still activated, **CONFIRM** voltage between pins **1** and **2** of harness connector to glycol pump by back-probing Deutsch connector.

- ii. **IF** voltage NOT within 0.3 volts of DC INPUT voltage,  
**THEN:**
  1. **DEACTIVATE** glycol override.
  2. **DISCONNECT** GCM 70-pin connector.
  3. **VERIFY** 0.3Ω or less between pin **2** of harness glycol pump connector and GCM pin **15** (pin **4** for #2 glycol pump of Seakeeper 35 and 40).

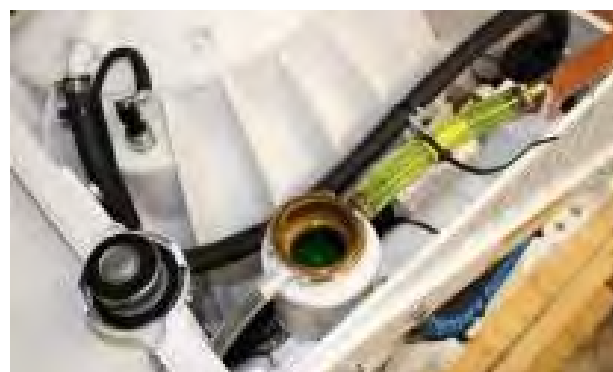
*Glycol flow may be seen through fill cap*

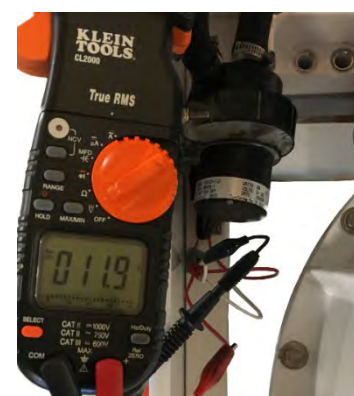
*Image of technician back probing glycol pump connector for voltage*

- c. **RECONNECT** DC INPUT connector.
- d. **ACTIVATE** glycol override.
- e. With multimeter and back-probes, **VERIFY** DC voltage at glycol pump connector within 0.3 volts of DC INPUT voltage.

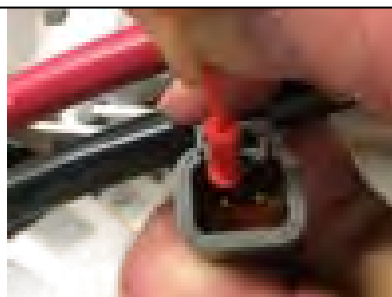
Close-up of the low DC input connector

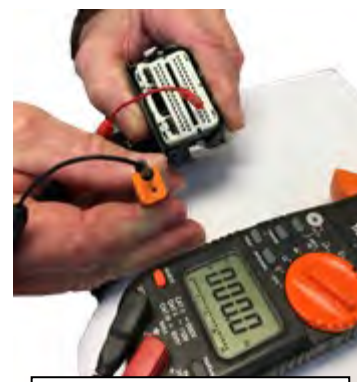
*Testing continuity between pin 2 and GCM pin 4 (for Seakeeper 5, 6, or pump 2 on a Seakeeper 35/30HD/40)*

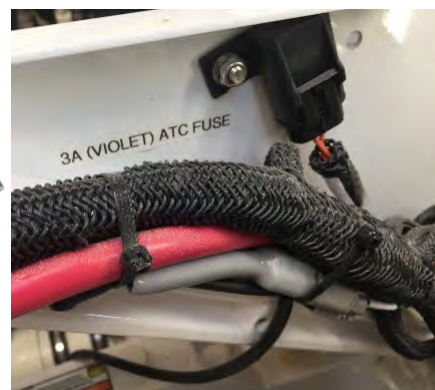
*Burnt element*

*Example of a blown ATC fuse*

3. **IF** fuse found blown, **THEN:**
  - a. **REPLACE** fuse.
  - b. **PERFORM** following to find cause of overcurrent:
    - i. **DISCONNECT** DC INPUT connector.
    - ii. **DISCONNECT** seawater power supply cable from seawater pump or relay.
    - iii. **DISCONNECT** 70-pin GCM connector.
    - iv. **DISCONNECT** SW PUMP OUT cable (5 m cable).

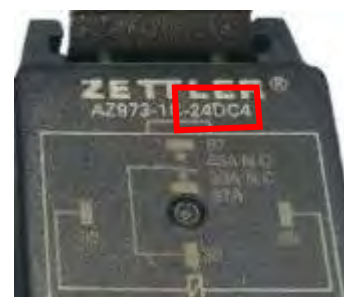
5. **TEST** seawater pump power relay as follows:
  - a. **TURN OFF** DC control power supply breaker.
  - b. **TURN OFF** DC seawater pump supply breaker.
  - c. **VERIFY** nameplate voltage of seawater pump power relay is 12 or 24 VDC rating (as shown in photo).
  - d. **IF** relay voltage marking improper for Seakeeper model, **THEN REPLACE** seawater pump relay with one of proper rating.

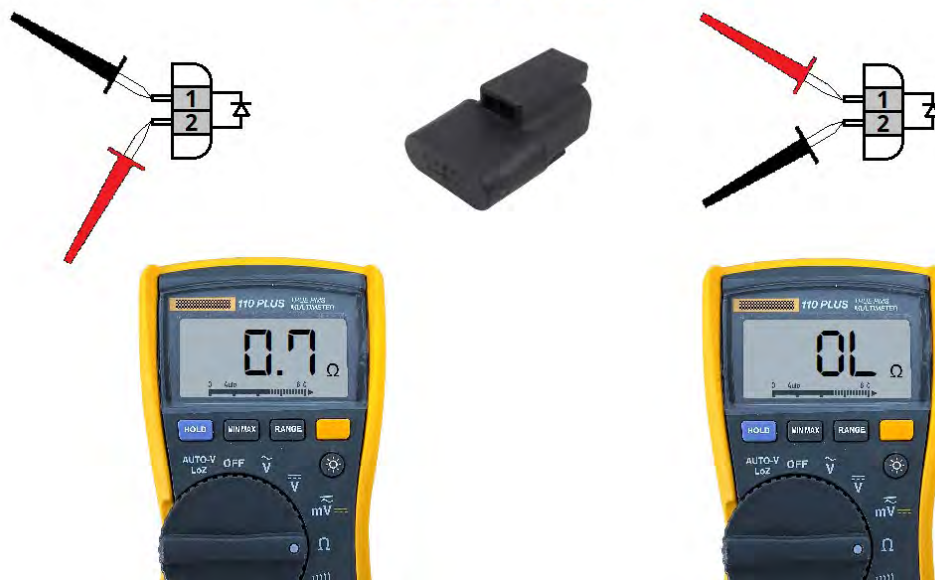
**DIODE MODULE**

- UNPLUG** diode module from wire harness.
- With multimeter in resistance mode, **TEST** for high (OPEN LOOP) resistance in one direction **AND** 0.5 to 0.8-ohm resistance in other direction on two pins of diode module.
- IF** both resistances measured are high or "OL," **THEN REPLACE** diode module.
- IF** both resistances measured are relatively low (continuity in both directions), **THEN REPLACE** diode module.

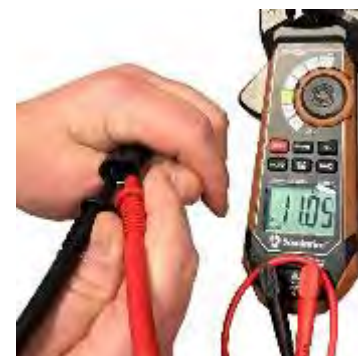
Meter in this photo is displaying 11.05 KΩ.

- a. **IF** resistance is higher than 50,000Ω **OR** less than 1000Ω,  
**THEN REPLACE** thermistor.
- b. Momentarily **CYCLE** DC Control Power to Seakeeper.
- c. **SPOOL** unit **AND VERIFY** alarm clear at display.

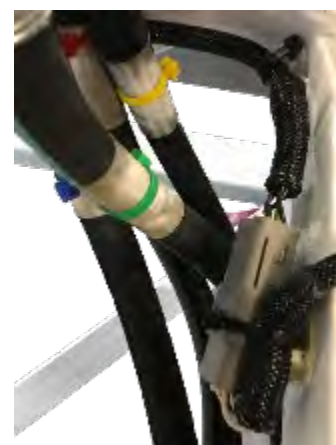
*Photo showing location  
of Guide Band connector  
inside foundation near  
guide band bracket and  
below manifold.*

- b. **WHILE** performing next two steps,  
**PRECESS** enclosure to each end stop and near 0°  
precession to take readings.
- c. On guide band harness, **CONFIRM** 0.3Ω or less between  
affected sensor's harness connector pin **1** and guide band  
connector Pin **3** (for Upper Thermistor) or pin **6** (for Lower  
Thermistor).
- d. On guide band harness, **CONFIRM** 0.3Ω or less between  
effected sensor's harness connector pin **2** and guide band  
connector Pin **5**.

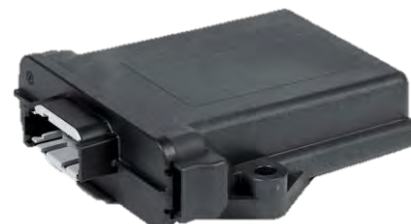
*Revision 1 IMU*

2. **INSPECT** IMU pins for damaged or bent pins.
3. **IF** revision 1 IMU, **THEN CONTACT** Seakeeper Product Support Team at support@seakeeper.com or emeasupport@seakeeper.com for instructions.
4. **IF** NO loose or damaged pins found, **THEN REPLACE** IMU.
5. **IF** loose pins/crimps found in connector, **THEN REPAIR** pin(s) **OR REPLACE** wire harness.

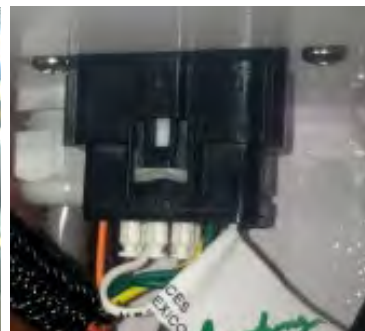
*Molex Connector of an AC-powered Seakeeper shown with white locking tab fully inserted*

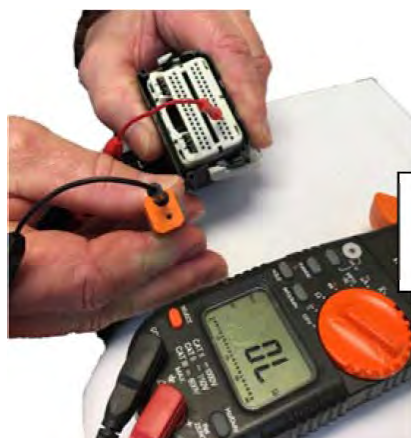
*Testing continuity  
between pin 1 and GCM  
pin 5 (for Solenoid 1)*

- b. **TEST** for SHORT between solenoid harness connector pin **1** and GCM pin **5**.

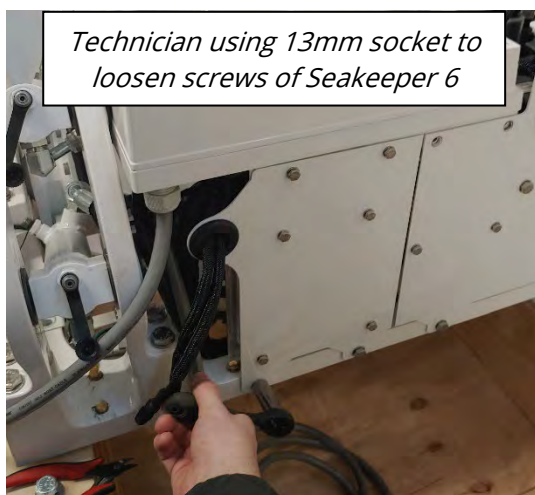
- a. Using a combination of 10 mm and 13 mm sockets, **REMOVE** screws at top of rear panel.
- b. Using 13 mm socket, **LOOSEN** screws at bottom of rear panel.

- c. **LIFT UP AND OUT** on top of rear panel.
- d. **DISCONNECT** GCM and IMU, as desired.
- e. **LOCATE** glycol pump attached at front panel on these models.

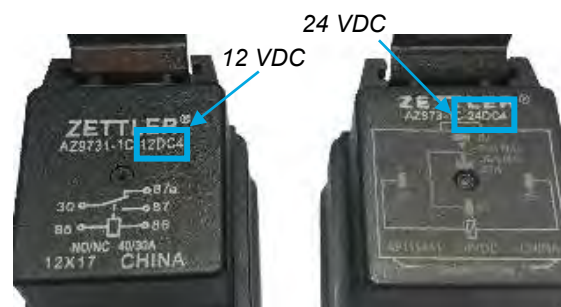
i. **DISCONNECT** power relay from wire harness.

ii. With a multimeter **CHECK** for 0.3Ω or less between pin 30 and pin 87A.

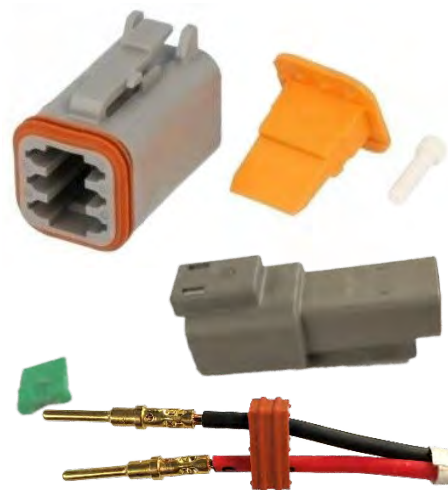
- b. **INSPECT** wire harness throughout foundation and guide band:
  - i. **ACTIVATE** Brake Override.
  - ii. **MANUALLY PRECESS** enclosure to check clearances for harness on guide band.
  - iii. **VERIFY** guide band sensor wiring is not rubbing on stringer or Seakeeper foundation/Gimbal cap.
  - iv. **DEACTIVATE** Brake Override.
  - v. **IF** Seakeeper 5/6 or larger,  
**THEN UNPLUG** guide band connector.

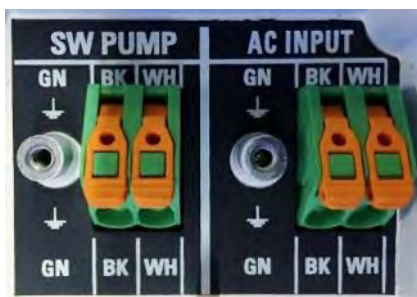
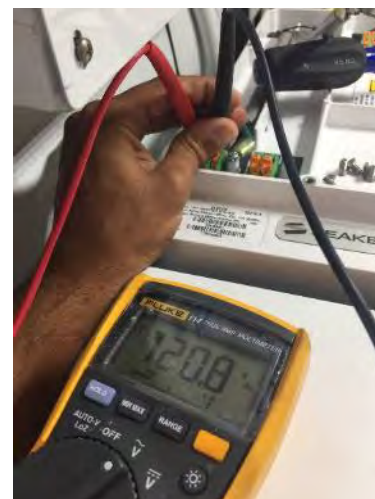
1. With Seakeeper locked and at zero RPM, **REMOVE** MDB cover.
2. **ENSURE** interior of MDB is free of moisture.
3. With a multimeter in "AC Volts" mode, **MEASURE** voltage at "AC INPUT" terminal.

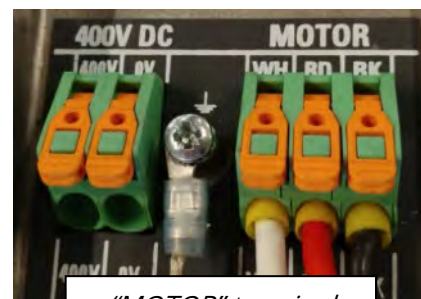
"MOTOR" terminal

5. **IF** voltage below 80 VAC or above 300 VAC, **THEN TROUBLESHOOT** vessel electrical supply.
6. **VERIFY** leads at "MOTOR" and "AC INPUT" terminals are in correct position by color.
7. **VERIFY** leads are crimped properly, fully inserted into terminal and locked firmly.
8. **IF** any issues found with leads, **THEN CORRECT** issues with motor cable leads.

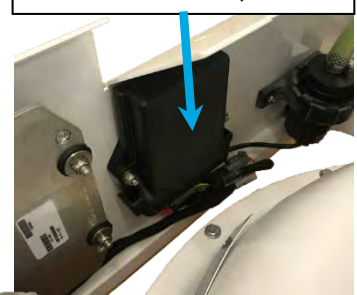
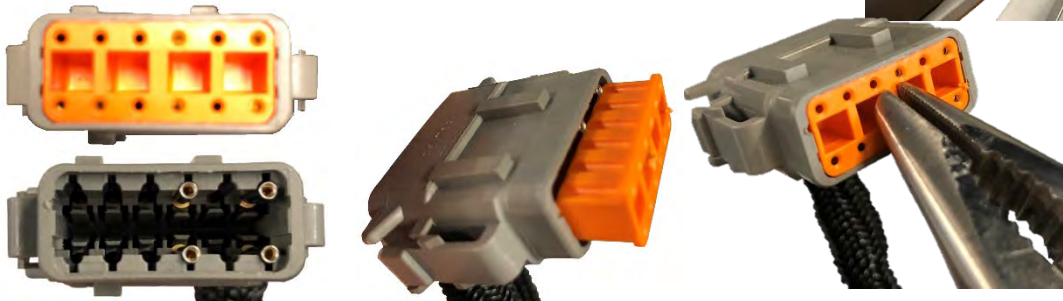
*IMU of Seakeeper 3*

1. **ENSURE** zero RPM on display or MFD app.
2. **TURN OFF** all breakers to Seakeeper.
3. **DISCONNECT** IMU harness connector.
4. **VISUALLY INSPECT** all wiring and pins of IMU:
  - a. **CUT** cable ties securing harness near IMU, as necessary.
  - b. **INSPECT** wiring near IMU for exposed leads with damage.
  - c. **INSPECT** IMU connector for loose wires or crimps.

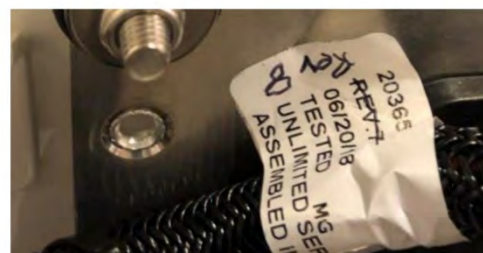
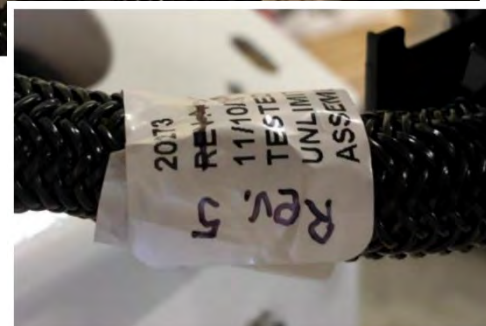
- b. **IF** Seakeeper 3 of S/N 3-0001 through 3-0443,  
**THEN VERIFY** harness label near GCM 70-pin connector reads "REV. 5," or later, as shown.
  - c. **IF** appropriate harness tag does not appear as in Steps 6.a or 6.b,

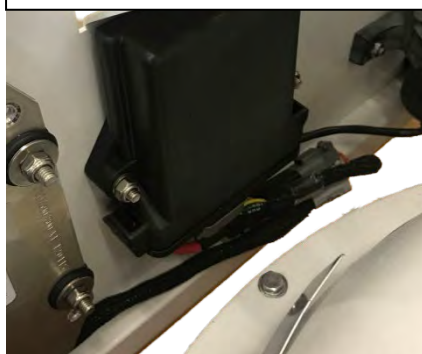
*IMU properly installed in a  
Seakeeper 3*

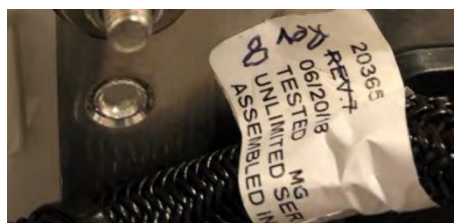
9. **INSPECT** wiring of harness around IMU for signs of damage.
10. **IF** wire harness appears damaged,  
**THEN REPLACE** wire harness.
11. **CYCLE** DC power to test alarm clear.
12. **IF** Seakeeper 2 or 3 model,  
**THEN PERFORM** following:
  - a. At GCM connection of wire harness (near front panel), **CHECK** tag for revision of harness.

*Seakeeper 2 harness should be Rev. 8 or later.*

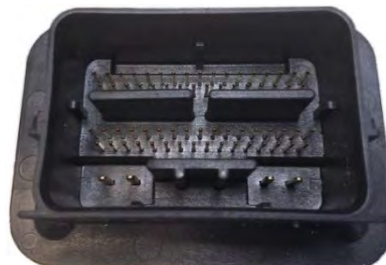
Motor Drive pins

GCM pins

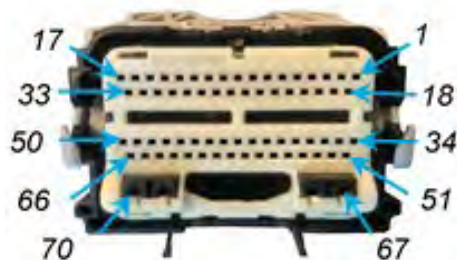
- a. **CONFIRM** below  $0.3\Omega$  between MDB pin **5** and GCM pin **36**.
- b. **CONFIRM** below  $0.3\Omega$  between MDB pin **6** and GCM pin **53**.

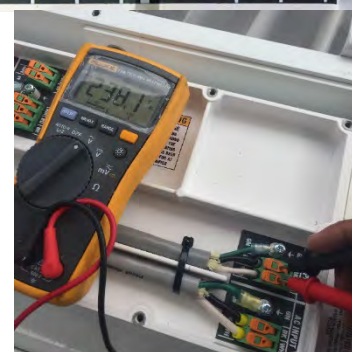
9. At display/MFD app, **ACTIVATE** SW Pump Override.
10. **CONFIRM** voltage at “SW PUMP” terminal is same as “AC INPUT” voltage.
11. **IF** seawater pump fails to operate,  
**THEN REMOVE AND BENCH TEST** seawater pump to verify pump operable.
- a. **IF** seawater pump motor failed,  
**THEN CONTINUE** in procedure.
12. **DEACTIVATE** SW Pump Override.
13. **TURN OFF** AC breaker to Seakeeper.

Testing SW Pump  
voltage

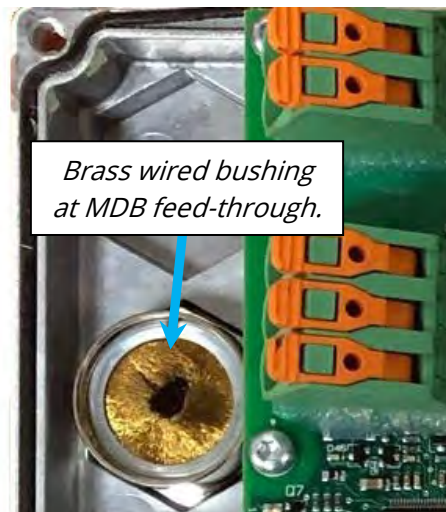
14. **IF** MDB has metallic-brushed grommet bushing in feed-through opening, as shown to right,  
**THEN REMOVE** wired bushing at MDB grommet.
15. **PERFORM** testing of motor leads per [SWI-124 - Seakeeper Motor Lead Testing](#).
16. With a multimeter in "DC Volts" mode, **TEST** voltage at "400V DC" terminal.
17. **IF** alarm is currently present and does not clear,  
**THEN:**
  - a. **INSERT** meter probes into 400v bus terminals.
  - b. With AC power aligned to drive, **CYCLE** DC power.
  - c. **ENSURE** meter reads 390 to 400 briefly before alarm triggers and it begins to drop.
18. **DOCUMENT** any visible damage found with a photograph and all test results.

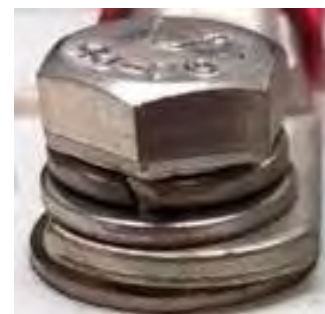
11. **RE-ATTACH** all motor cable leads to respective terminal.
12. **TORQUE** terminal leads per [Torque Specifications](#) section.
  - a. **ENSURE** lock washers are flattened after torquing as shown.
13. **INSTALL** cover at motor drive cable contact posts and High DC current input terminals.
14. **TURN ON** all Seakeeper breakers.
15. **IF** issue persists,  
**THEN CONTINUE** to Section 3 (next page).

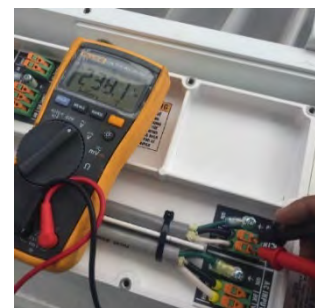
*Testing SW Pump  
voltage*

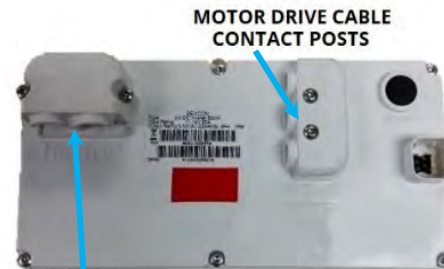
*MDB Ground  
to foundation*

*Motor Frame  
Ground to MDB*

**HIGH DC  
CURRENT INPUT**

**SEAKEEPER 2 & 3 MDB  
(BOTTOM VIEW)**

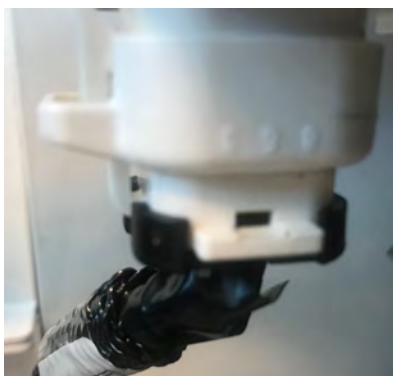
2. **ENSURE** flywheel at zero RPM at display or MFD app.
3. **TURN OFF** all Seakeeper power breakers.
4. **VERIFY** wire harness connector at Motor Drive is fully inserted.

Photo shows  
Connector  
Position  
Assurance (CPA)  
device fully  
inserted on an  
AC-powered

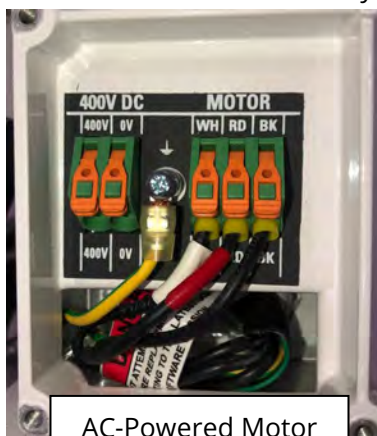
5. **VERIFY** motor terminal leads securely attached.

AC-Powered Motor  
terminals

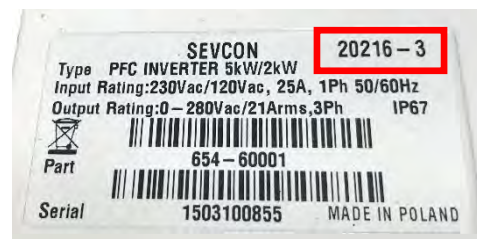
- a. **IF** MDB revision 2, **THEN:**
  - i. **REPLACE** MDB.
  - ii. **CONTINUE** in procedure.
- b. **TURN OFF** AC breaker to Seakeeper.
- c. **OPEN** MDB cover.
- d. **INSPECT** for metallic wire bushing in grommet of motor power cable.
- e. **IF** bushing present, **THEN:**
  - i. **DISCONNECT** motor power wires from MDB terminal.
  - ii. **REMOVE** bushing from grommet.
  - iii. **APPLY** heat shrink shroud around cable at grommet.
  - iv. **RECONNECT** motor power cable wires to MDB terminal.

*Brushed bushing  
of motor power  
cable grommet*

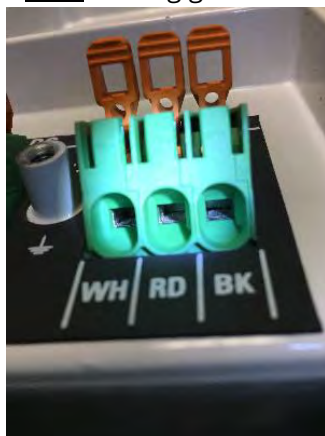
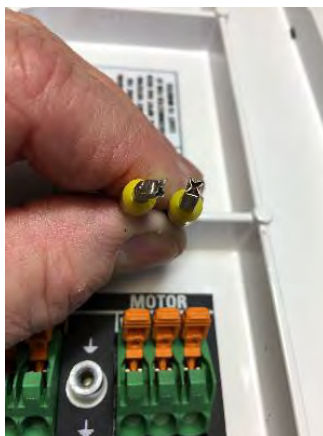
13. **REMOVE** MDB cover.
14. **VERIFY** crimps of each motor cable lead are securely fastened **AND** making good contact in terminal.

*This damaged insulation caused DSPPF Fault in this Seakeeper.*

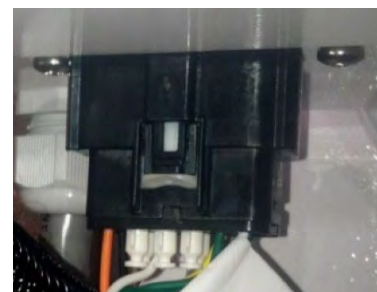
*An AC-powered model's MDB connector securely fastened.*

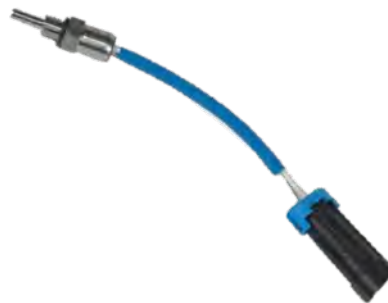
*Harness connector to  
thermistor*

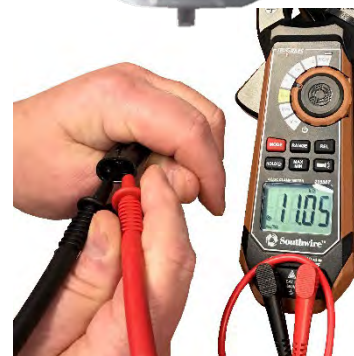
Thermistor connection to harness

Meter in this photo is displaying 11.05 KΩ.

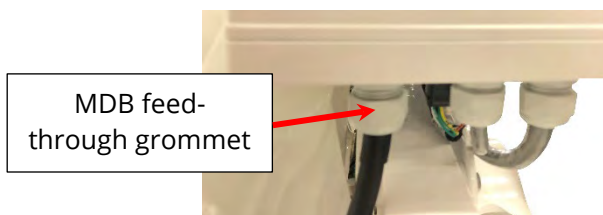
a. **LOOSEN** MDB feed-through grommet.

b. **EXAMINE** motor drive cable insulation at grommet.

c. **IF** insulation damage found  
**THEN CONTACT** Seakeeper Product Support Team at [support@seakeeper.com](mailto:support@seakeeper.com) or [emeasupport@seakeeper.com](mailto:emeasupport@seakeeper.com).

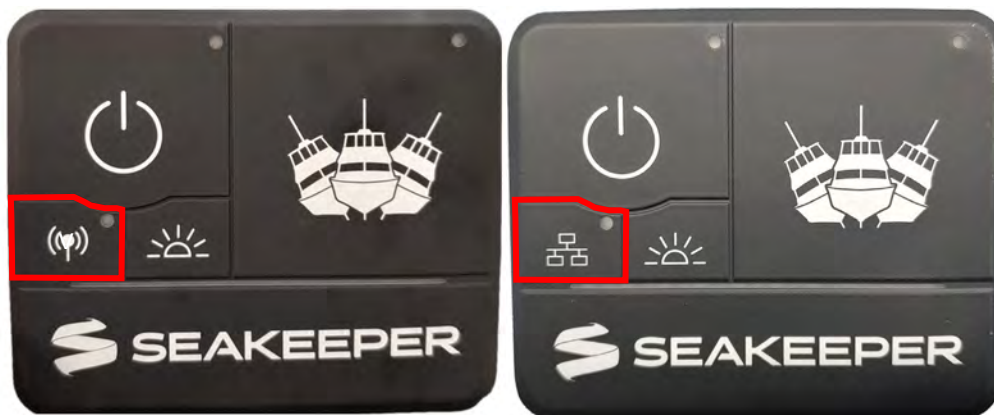
- b. On ConnectBox, **CYCLE** between HTML settings by holding down Ethernet/Connectivity button for 10 seconds or until spool bar LEDs strobe right to left or left to right.
- c. **IF** mode fails to switch,  
**THEN REPEAT** Step 5.b.

ConnectBox software **3.0.4-de5310b9**, and after, has only two synchronization modes for MFD connectivity:

- 1) DHCP server function off (for Garmin, Raymarine, and Furuno MFDs) indicated by spool bar strobing from right to left.
- 2) DHCP server function on (for NAVICO brand MFDs) indicated by spool bar strobing from left to right.

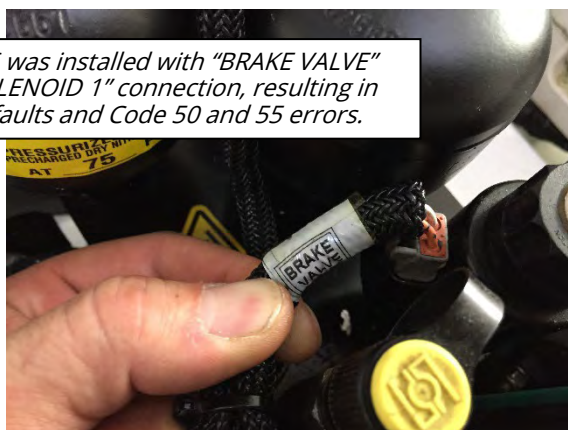
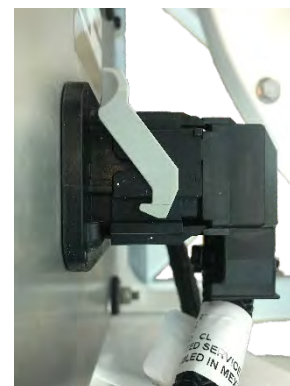
*This Seakeeper 6 was installed with "BRAKE VALVE" connector in "SOLENOID 1" connection, resulting in multiple travel faults and Code 50 and 55 errors.*

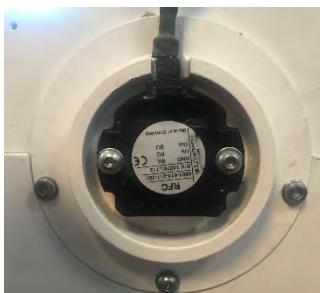
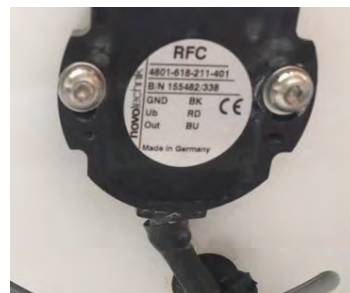
7. **ENSURE** angle sensor installation is flat against foundation and securely fastened.
8. **ENSURE** angle sensor mounted with silver manufacturer's label facing away from Seakeeper.

*This notch should be in same orientation as sensor's lead.*

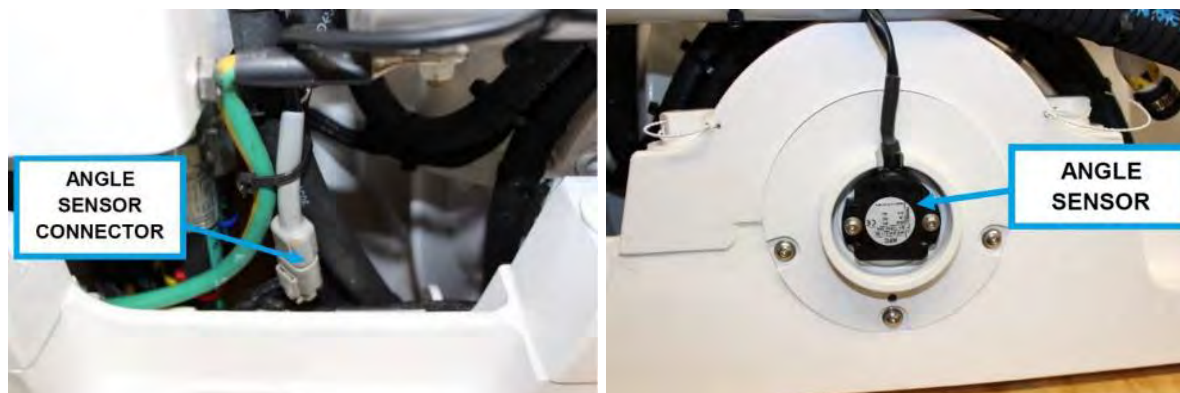
- c. **ENSURE** brake override activated.

Negative precession angle is precession of enclosure in forward direction.

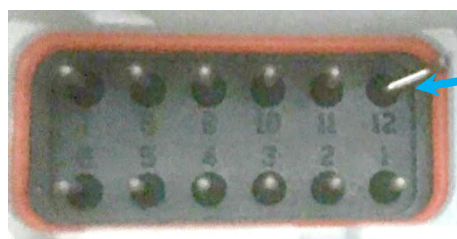
*This damaged IMU pin prevented proper seating of harness connector.*

3. **IF** any loose wires or crimps found,  
**THEN REPAIR** IMU connector.
4. **IF** IMU found loose,  
**THEN FASTEN** IMU securely.

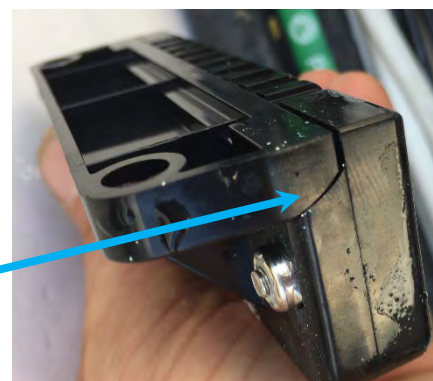
*This damaged IMU housing allowed water intrusion.*

5. **IF** water intrusion found,  
**THEN INSPECT** other connectors (GCM 70-pin connector and MDB harness connector) of Seakeeper for water.
6. **IF** water intrusion found,  
**THEN REPLACE** wire harness.

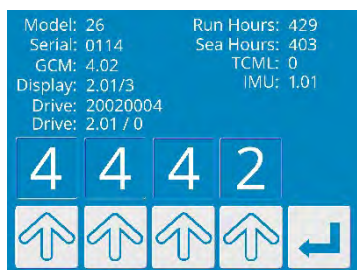
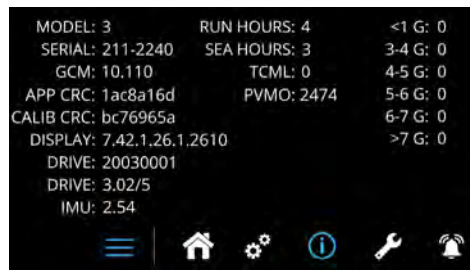
- d. **MAINTAIN** camera focused on enclosure.
  - e. **RECORD** minimum of 30 seconds of sphere precession.
  - f. **PHOTOGRAPH** display or MFD app Information screen of Seakeeper.

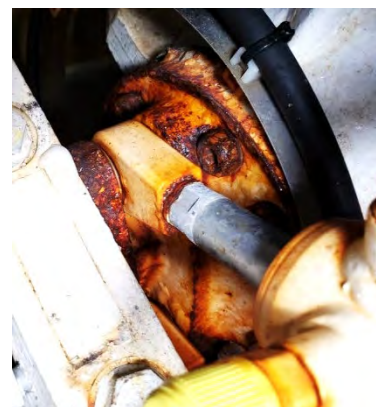
*Seakeeper 3 with severe corrosion at rod end clevises, pins, and gimbal shafts*

In severe cases of corrosion, such as when a unit has been submerged, it will be necessary to replace the Seakeeper. Additionally, if severe corrosion is caused by environmental issues in the space, the Seakeeper may need to be removed for a complete restoration in a shop area. Reinstallation should always follow the guidelines outlined in the applicable model's Installation Manual. Installation manuals can be found at [manuals.seakeeper.com](http://manuals.seakeeper.com).

1. **ENSURE** flywheel at zero RPM at display or MFD app.
2. **DEENERGIZE** all power to Seakeeper.
3. **REMOVE** top cover panels from Seakeeper.
4. **REPLACE** components that are corroded beyond reasonable restoration.
  - a. **IF** multiple components corroded beyond restoration, **THEN CONTACT** Seakeeper Product Support Team at [support@seakeeper.com](mailto:support@seakeeper.com) or [emeasupport@seakeeper.com](mailto:emeasupport@seakeeper.com) to consider other options.
  - b. **IF** brake hose fittings are severely corroded, **THEN REPLACE** brake hoses.

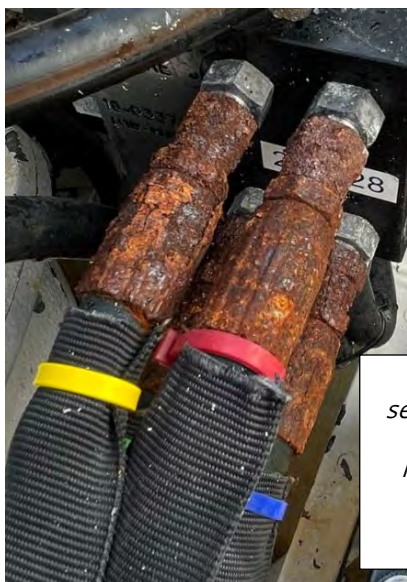
*With corrosion this severe, restoration may be futile in stopping leaks and preventing future low brake pressure alarms.*

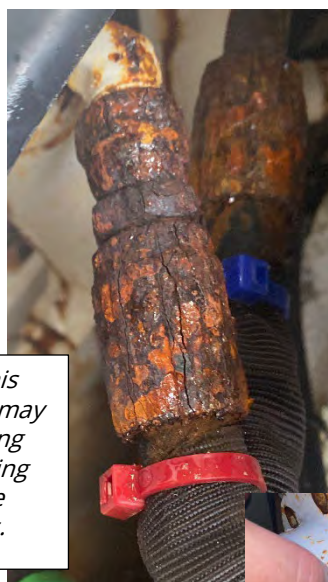
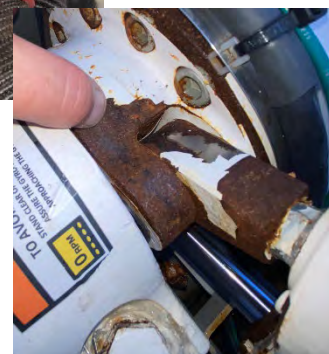
- c. **IF** brake pin hardware is corroded (pin retaining rings) or severe corrosion around brake pins, **THEN REPLACE** brake pin hardware and all bushings per [SWI-109](#).

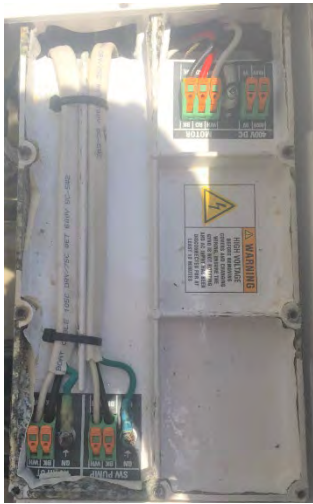
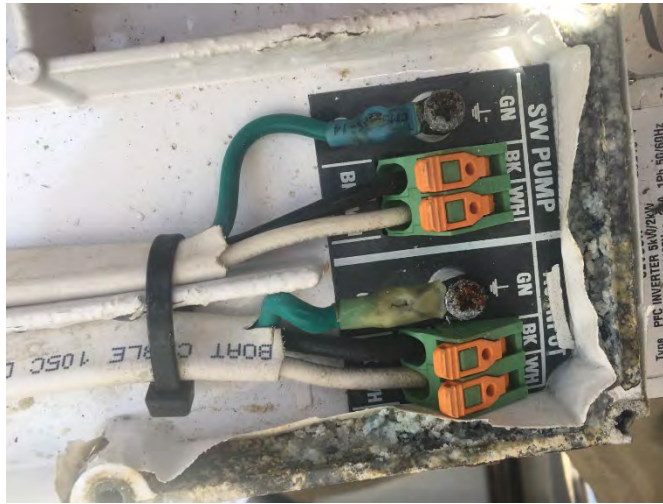
- d. **IF** indication of corrosion at an AC-powered Seakeeper Motor Drive, **THEN:**
- REMOVE** Motor Drive cover.
  - INSPECT** drive internal surfaces.
  - IF** any evidence of corrosion or moisture intrusion present, **THEN REPLACE** motor drive per [SWI-094](#).

- IF** electronic components discovered with severe corrosion, **THEN REPLACE** affected components, as needed.
- REPLACE** other corroded components or hardware as necessary.

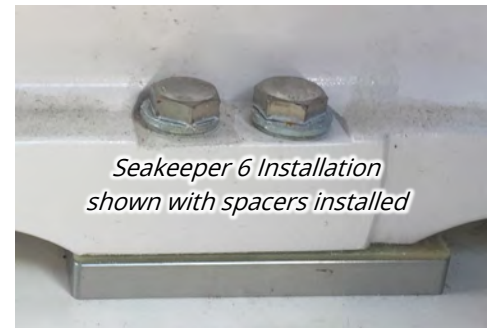
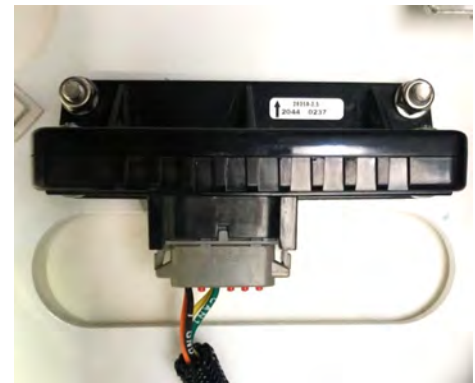
- a. **REVIEW** alarm history at display or MFD app.
  - i. **ADDRESS** motion-related alarm codes per applicable troubleshooting guide (Codes 19, 26, 27, 37, 38, 39, 50, 55, 56, 72, 76, 78, 79, 80, 111, or 115).
  - ii. **RECORD** alarms in history.
- b. **PHOTOGRAPH** display Information screen.
- c. **CHECK** for proper mounting screw torques per [Torque Specifications](#) section.
- d. **IF** Seakeeper 6,  
**THEN ENSURE** aluminum spacers installed at each corner of foundation.
- e. **ENSURE** IMU mounted securely to panel by two bolts and nuts.
- f. **ENSURE** IMU housing is intact and no cracks present.
- g. **ENSURE** panel to which IMU mounted is securely fastened to foundation.
- h. **ENSURE** IMU mounted in correct orientation per applicable model Electrical Subsystem or Assembly drawing.
